## Earthquake Reconnaissance: Guatemala, February 1976

D. H. Weichert

Volume 3, Number 3, August 1976

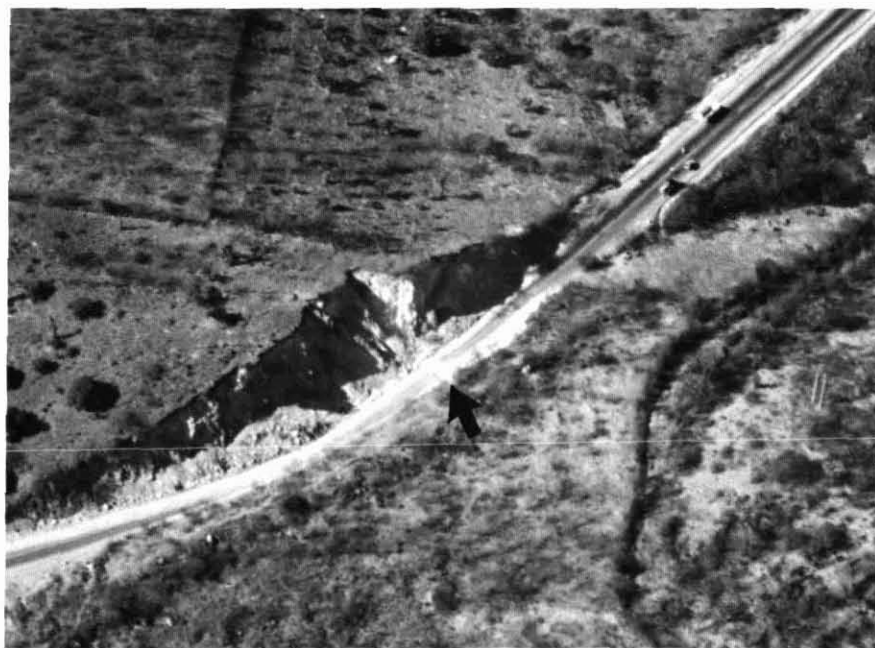
writer and some engineering colleagues found it difficult to convince themselves by air observation of the "continuity" of the fault trace in an area where our geologist friends had already established its existence. Figures 3 and 4 show examples of easily visible surface offset and cracking.

**Figure 4**  
Road crossing of the fault, looking north. The far side has moved left, as confirmed by the offset in the white centerline of the road.

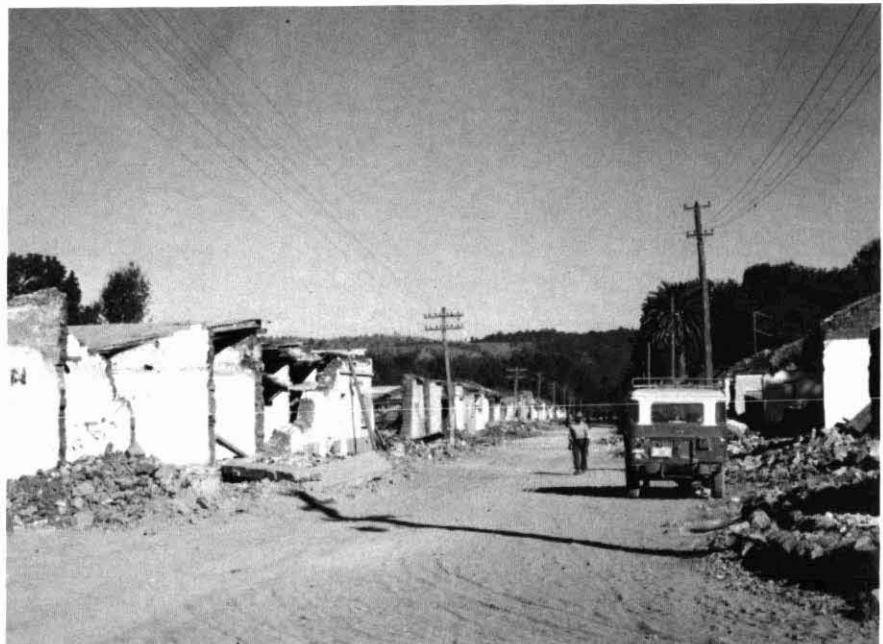
**Figure 5**  
*Chimaltenango: typical adobe damage, about 20 km from surface break.*

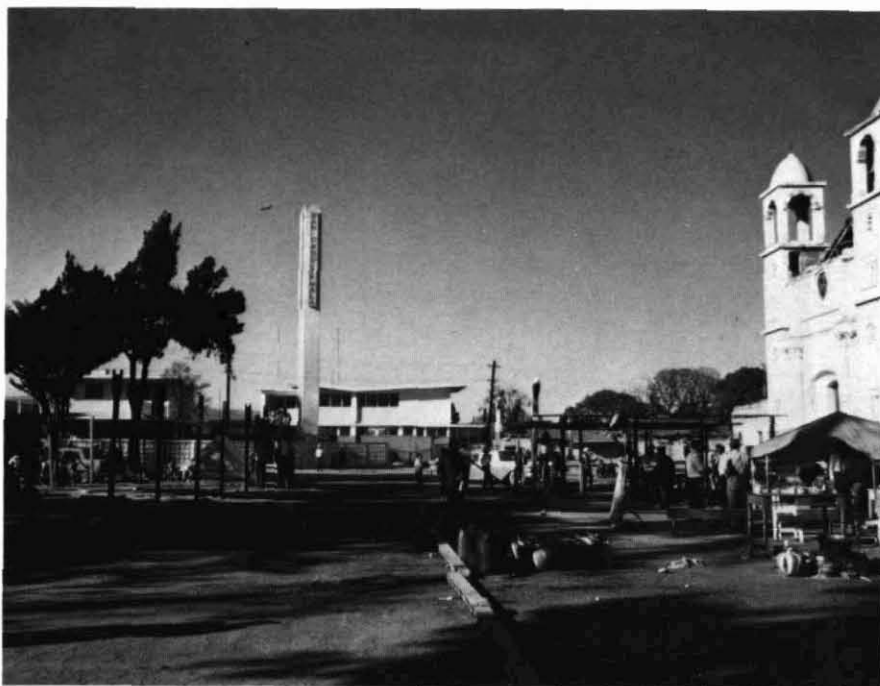
**Figure 6**  
*Chimaltenango: modern bank building and decorative brick wall remained standing.*
