Applied Sedimentology in an Urban Environment — the Case of Scarborough Bluffs, Ontario: Canada's Most Intractable Erosion Problem

N. Eyles, C. W. Eyles, K. Lau and B. Clark

Volume 12, Number 3, September 1985

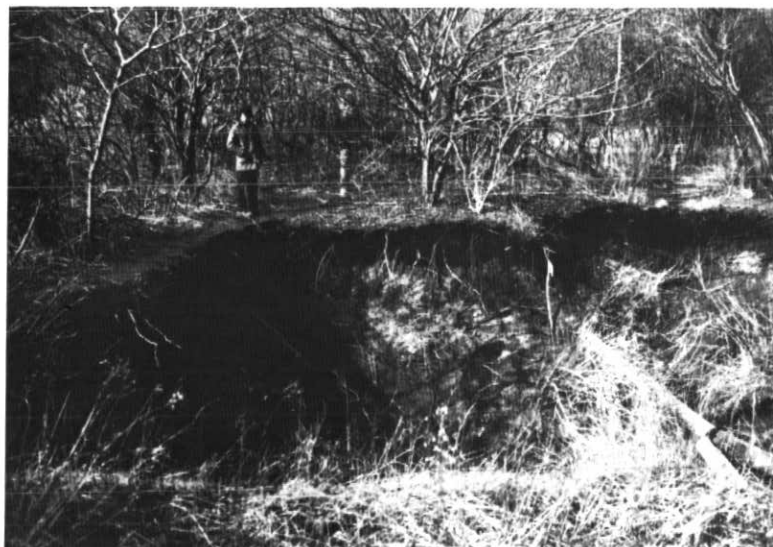
Figure 9 **B)** Large cave-like pipe (arrowed) associated with "sag basins" of sand formed by soft-sediment deformation on the upper surface of diamict units; **C)** 2 to 4: the formation of large erosional scallops, by spring sapping, in response to groundwater focussing within "sag basins" on top of impermeable Sunnybrook diamict in the area of Sylvan Park (Fig. 3). Unfocussed seepage occurs where no sag basins are present (1); **D)** Head of scallop showing collapsed area over subsurface pipe

Planar slopes are undergoing parallel retreat in response either to groundwater seepage and piping (Fig. 9), with associated sloughing of surface sediment, or by minor, shallow, slab-like slides along the stress relief joints parallel to the cliff face (Fig. 10). Both these processes are most active in the spring. Debris accumulates at the slope foot as debris flows, which subsequently stabilize as a thick talus slope, and is removed during the following summer and fall by wave activity. Data indicate that during the winter, groundwater is prevented from escaping and high porewater pressures build up behind the frozen face to be released very rapidly as the slope thaws (Fig. 11). The role of freeze-thaw activity in acting to elevate porewater pressures in slopes and promote "spring sapping" is well-known in seasonally-cold climates. On the steeper slopes in areas of lithological homogeneity, slab-like masses of sediment are released from stress relief joints and accumulate as a steep talus slope at the cliff foot. The best example of this activity is seen to the west of Bluffers Park where the stratigraphically lowermost diamict unit and associated fine-grained facies fill in one of the large channels on the delta "basement". Here the entire cliff, up to 50 m high, overhangs the cliff foot in a series of spectacular arêtes (Fig. 10A). The progressive degradation of a large "needle"-like arête can be shown very clearly by a sequence of photographs taken by the late A.P. Coleman in the years between 1900 and 1936 (Fig. 10B). Individual arêtes are defined by deeply-cut gullies and resemble large cathedral buttresses (hence the name Cathedral Bluffs; Fig. 3). Erosion appears to have been accelerated along this stretch of the coast as a result of the beach starvation and stripping caused by the Bluffers Park Marina, though the magnitude of wave impact stresses at this site has yet to be determined.

Scalloped slopes, unlike the planar slopes described above, are not stable forms and appear to undergo a distinct sequential evolution. Immature scallops narrow downward and discharge via chutes well above lake level. The predominant process occurring within the scallop is spring mud flow activity and subsequent summer fluvial dissection by rills. Scallops enlarge by headward retreat and downcutting and are separated by large arêtes fronted by steep planar slopes described above (Fig. 12). The role of "sag basins" on the upper surface of the Sunnybrook diamict in focusing groundwater seepage and accelerating scallop growth rates has already been discussed above (Fig. 9). The scallops are

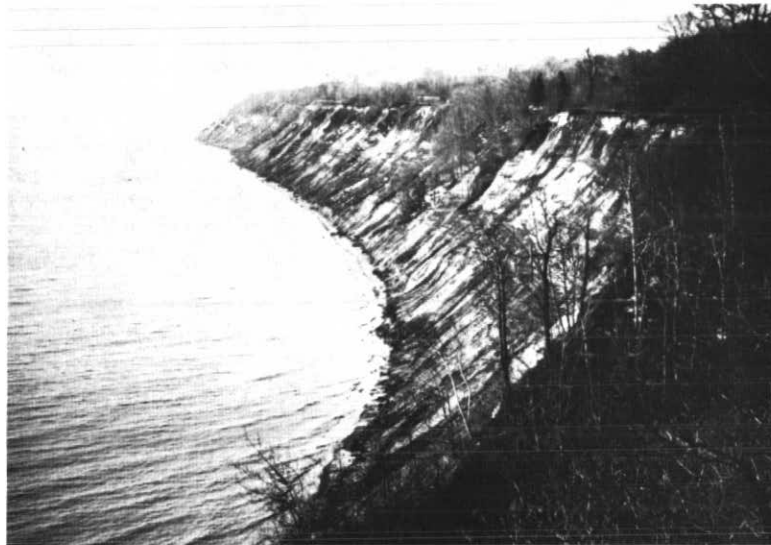
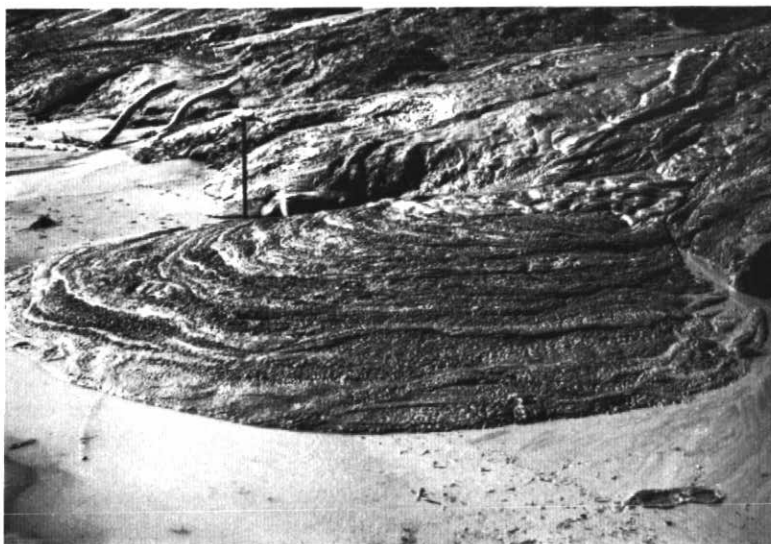
Figure 11 A) Planar slopes at time of maximum spring snow melt; mudflows are moving downslope and have covered the beach area (B). Thaw of frozen bluff sediments allows high porewater pressures, built up behind the frozen face, to be dissipated thereby releasing water and generating mudflow activity. Note oblique wave approach to the coast which is responsible for littoral drift system (Fig. 2)
