## Some Twentieth-Century Canadian Earthquakes

Stevens, A. E. (1977). Some Twentieth-Century Canadian Earthquakes. *Geoscience Canada*, 4(1), 41–45.

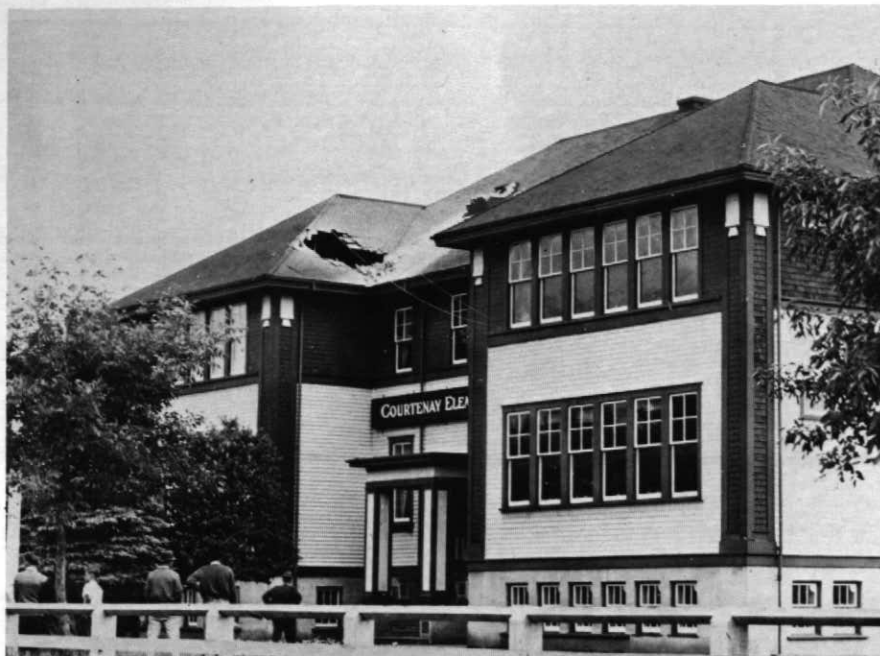
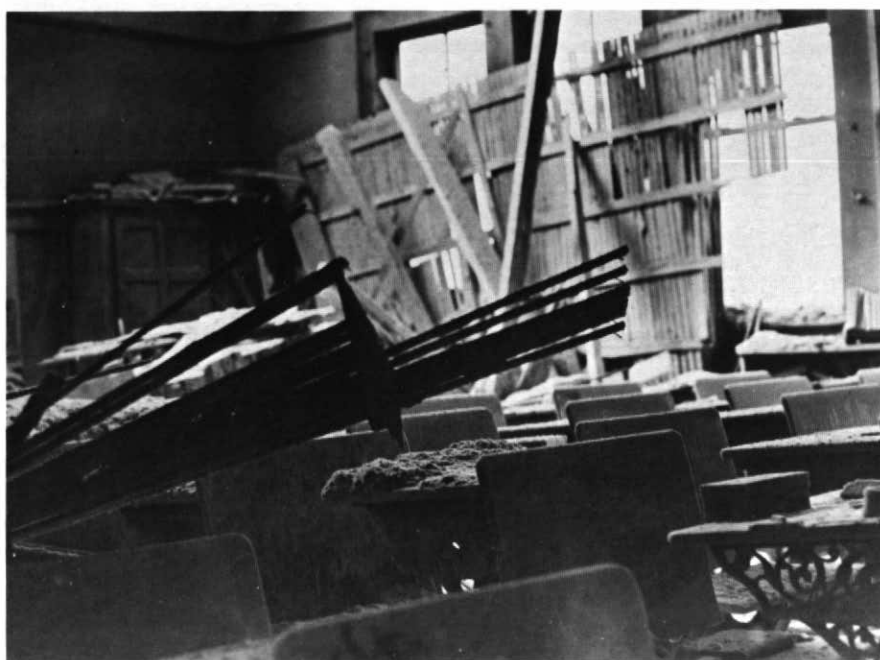
Chimney damage sometimes induces other damage. Figure 3b shows the interior of a schoolroom in Courtenay about 25 km south of the epicentre of the 1946 earthquake. Fortunately, the shock occurred about 10 a.m. local time on a Sunday morning when the classroom was empty. Damage here was caused when the large school chimney fell through the roof. In Courtenay about 25 per cent of the chimneys were damaged, mostly in the central part of town. Windows and bottles were cracked in some stores.

**Figure 3**  
June 23, 1946. Elementary School,  
Courtenay, B.C. The chimney, located above

the front entrance, fell sideways through the  
roof into a classroom. (Figs. 16 and 15,  
respectively, in Hodgson, 1946).
