## Active Earth

## Erosion at Point Grey, British Columbia

## Howe Sound Debris Flows

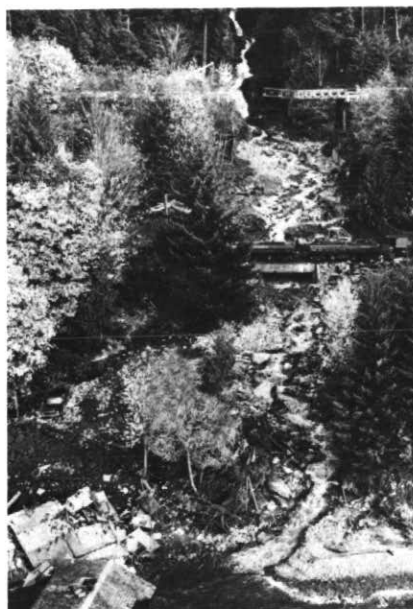
**Figure 2** View of the mouth of M-Creek. Note remainders of demolished residence drifting in the sea and highway bridge under reconstruction.

astride the narrow channel of M-Creek. Soon thereafter a debris flow scoured down the torrent channel (average gradient 50%) and, having attained considerable momentum, took out the bridge carrying Highway 99; it then picked up an unoccupied residence along the shore and pushed it out to sea (Fig. 2). As visibility on the highway at the time was poor, the wide slash across the road bed was noticed only too late by drivers of several vehicles that plunged into the gap. The accidents claimed 9 lives.
