# Applied Sedimentology in an Urban Environment — the Case of Scarborough Bluffs, Ontario: Canada's Most Intractable Erosion Problem

N. Eyles, C. W. Eyles, K. Lau et B. Clark

Volume 12, numéro 3, septembre 1985

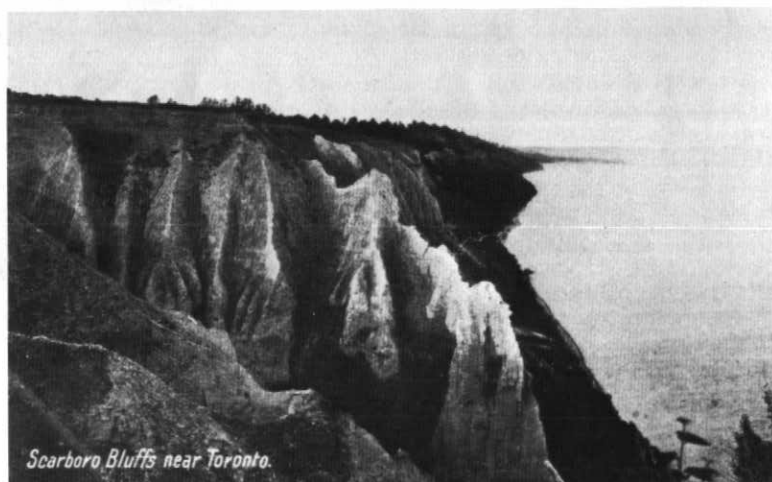
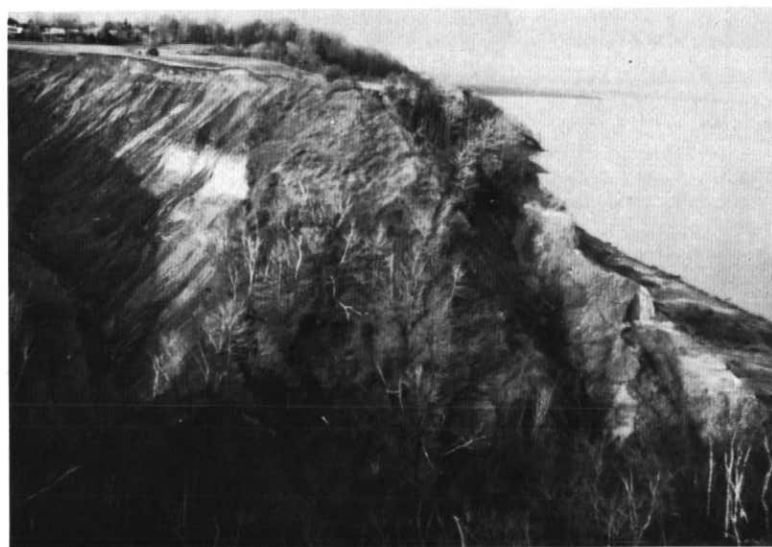
**Figure 5** A) Popular postcard of the early 1920's, depicting the view east from Sunnybrook over Cathedral Bluffs with their intensely dissected slopes and arêtes resembling cathedral buttresses. The present day view (B) shows largely planar slopes; it is evident from other evidence that gully and arêtes experience cyclic development over time from planar slopes to well-developed gully systems

(Fig. 5). A benchmark source is the first topographic map of the area by Augustus Jones completed in 1793 during the original township survey. In 1903, Professor A.P. Coleman of the Geology Department at the University of Toronto compared the then bluff crest positions with those identified by Jones and those shown on a later 1864 map by F.F. Passmore. Coleman (1903) established an average retreat of  $0.71 \text{ m yr}^{-1}$  which compares with the averaged rates of between  $0.31$  and  $0.76 \text{ m yr}^{-1}$  established by more recent studies. These figures mean very little however, since they hide real annual erosion rates of between  $0$  and  $15 \text{ m}$ . Detailed comparisons between different studies is also complicated by problems of location and reidentification of reference points. Nonetheless, these figures allow rough computations to be made of the total volumes of eroded sediment being added to the nearshore lake sediment system each year. For example, an annual average loss of  $0.5 \text{ m yr}^{-1}$  represents some  $400,000 \text{ m}^3$  of sediment. These figures are comparable to data available for other eroding coastlines of unconsolidated Quaternary glacial sediments in the Great Lakes Basin (Gelinas and Quigley, 1973; Haras and Tsui, 1976; Quigley *et al.*, 1977). What makes the loss at Scarborough so critical, however, is that erosion is occurring in a heavily urbanized area. As early as 1912, in an unpublished report to R.C. Harris, then Commissioner of Works at City Hall, Coleman argued that a wide verge be left empty inland of the cliff crest. He argued that no structures should be allowed within this "cordon sanitaire" which was recommended to be sufficiently broad to allow for at least 200 years of erosion. The plans for cliff top subdivisions conceived in the 1920's (Fig. 4) suggests that the real value of this advice was not realized.

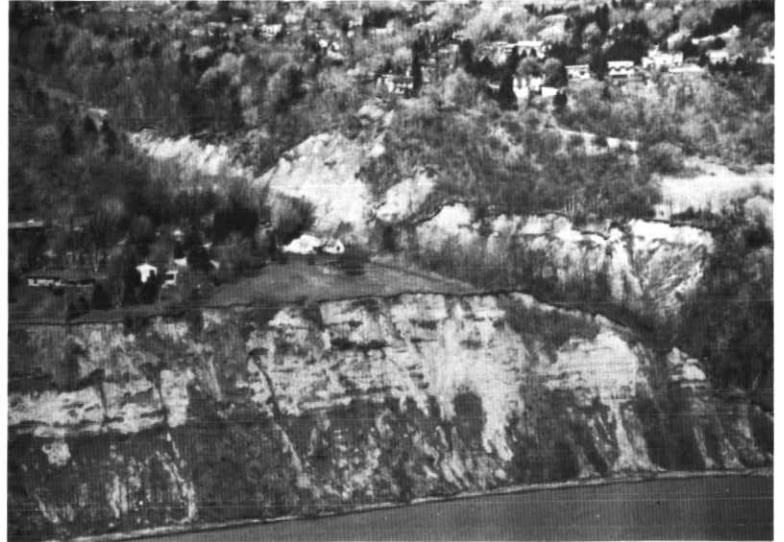
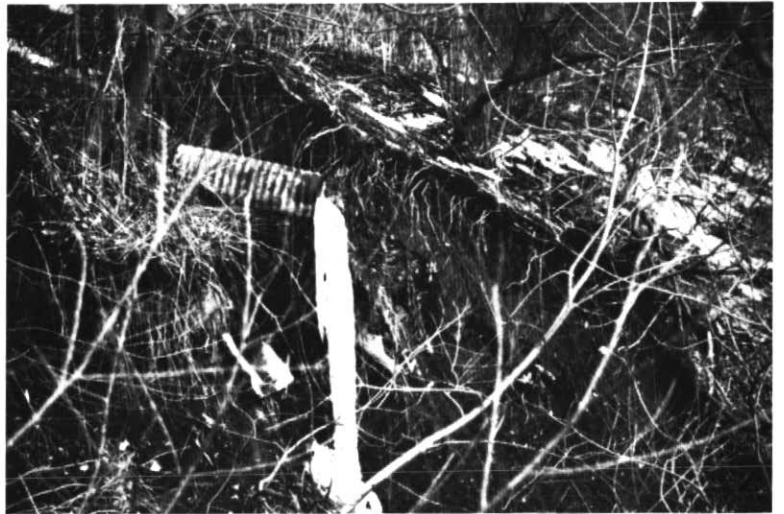
**Figure 6** **A)** Bellamy Ravine, one of the most impressive of the ravines along Scarborough Bluffs. Its headward development and rapid downcutting have been aided by rapid urbanization of its catchment (Fig. 4) and uncontrolled storm runoff (**B**)

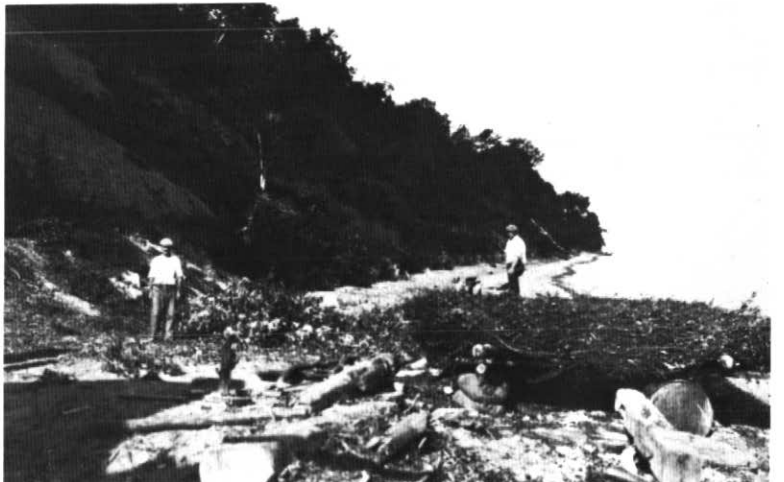
**Figure 7** Early attempts at remedial work: "Mississippi mats" constructed by laying brushwood, mostly willow, on a wooden frame, being placed around the intake for the Scarborough Waterworks (Fig. 3) in the mid 1930's (from the collection of A.P. Coleman)

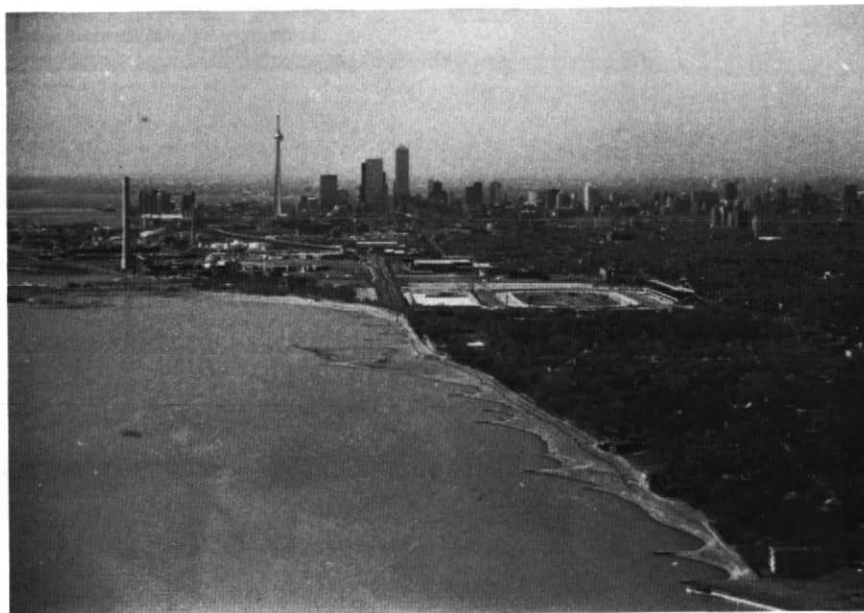
**Figure 8** View looking west of the Eastern Beaches (Fig. 2) toward the downtown core showing groynes and resulting entrapment of littoral sediment transported by the long shore drift system

from direct wave attack. Construction of groynes results in local beach build-up and toe protection but this is at the expense of adjacent properties downcurrent whose beaches become starved and ultimately disappear. Figure 7 shows early attempts at carrying out toe protection using "Mississippi mats" composed of brushwood on timber frames. Modern slope-foot berms "armoured" to withstand winter storms are shown in Figures 14 and 15.

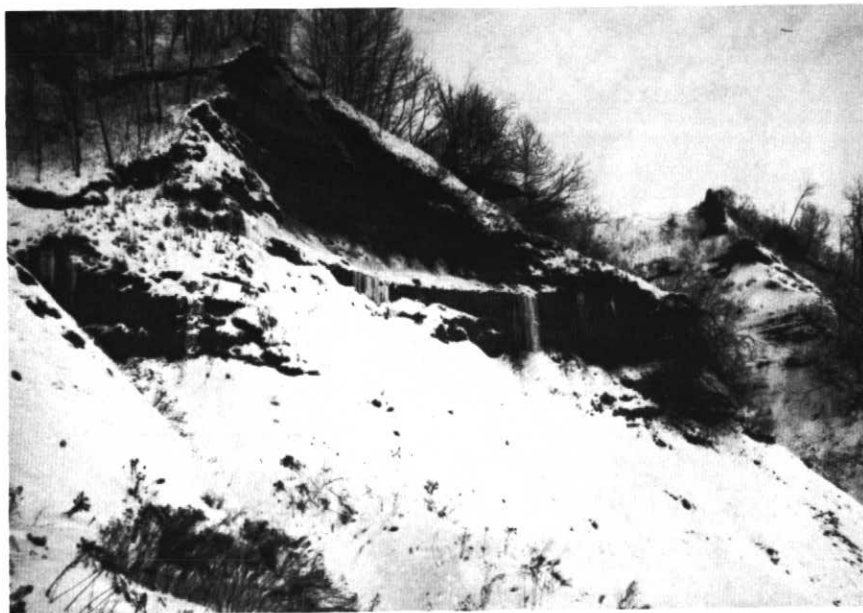
**A**

**Figure 9 A)** Icicles marking horizons of "pipes" formed by subsurface water seepage along juxtaposed sand and mud lithologies at the contact of the deltaic Scarborough Sands and Scarborough Clays (Fig. 3)

Planar slopes are undergoing parallel retreat in response either to groundwater seepage and piping (Fig. 9), with associated sloughing of surface sediment, or by minor, shallow, slab-like slides along the stress relief joints parallel to the cliff face (Fig. 10). Both these processes are most active in the spring. Debris accumulates at the slope foot as debris flows, which subsequently stabilize as a thick talus slope, and is removed during the following summer and fall by wave activity. Data indicate that during the winter, groundwater is prevented from escaping and high porewater pressures build up behind the frozen face to be released very rapidly as the slope thaws (Fig. 11). The role of freeze-thaw activity in acting to elevate porewater pressures in slopes and promote "spring sapping" is well-known in seasonally-cold climates. On the steeper slopes in areas of lithological homogeneity, slab-like masses of sediment are released from stress relief joints and accumulate as a steep talus slope at the cliff foot. The best example of this activity is seen to the west of Bluffers Park where the stratigraphically lowermost diamict unit and associated fine-grained facies fill in one of the large channels on the delta "basement". Here the entire cliff, up to 50 m high, overhangs the cliff foot in a series of spectacular arêtes (Fig. 10A). The progressive degradation of a large "needle"-like arête can be shown very clearly by a sequence of photographs taken by the late A.P. Coleman in the years between 1900 and 1936 (Fig. 10B). Individual arêtes are defined by deeply-cut gullies and resemble large cathedral buttresses (hence the name Cathedral Bluffs; Fig. 3). Erosion appears to have been accelerated along this stretch of the coast as a result of the beach starvation and stripping caused by the Bluffers Park Marina, though the magnitude of wave impact stresses at this site has yet to be determined.

Scalloped slopes, unlike the planar slopes described above, are not stable forms and appear to undergo a distinct sequential evolution. Immature scallops narrow downward and discharge via chutes well above lake level. The predominant process occurring within the scallop is spring mud flow activity and subsequent summer fluvial dissection by rills. Scallops enlarge by headward retreat and downcutting and are separated by large arêtes fronted by steep planar slopes described above (Fig. 12). The role of "sag basins" on the upper surface of the Sunnybrook diamict in focusing groundwater seepage and accelerating scallop growth rates has already been discussed above (Fig. 9). The scallops are

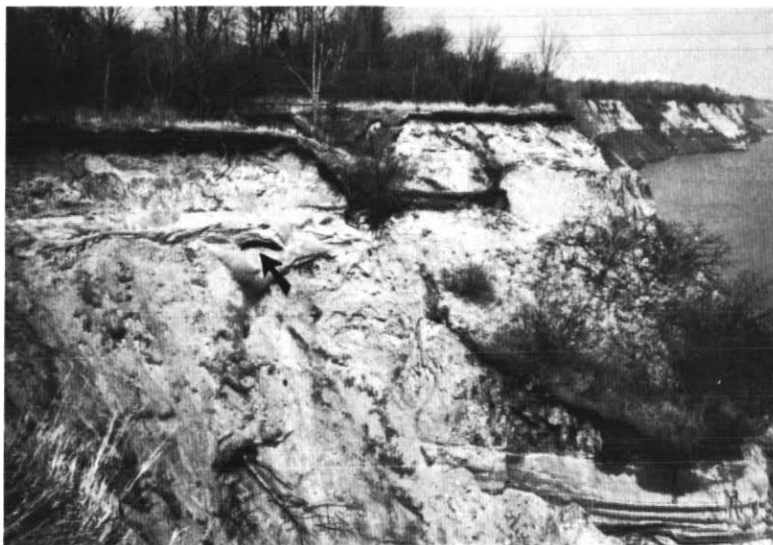
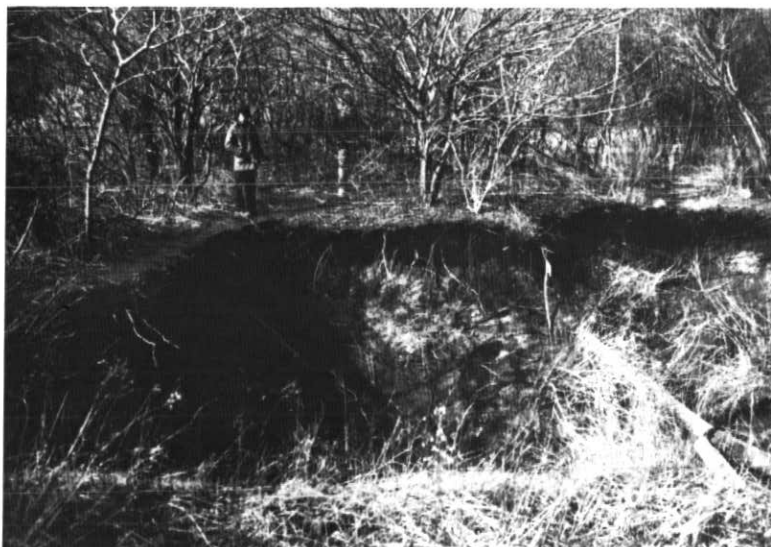
**Figure 9** **B)** Large cave-like pipe (arrowed) associated with "sag basins" of sand formed by soft-sediment deformation on the upper surface of diamict units; **C)** 2 to 4: the formation of large erosional scallops, by spring sapping, in response to groundwater focussing within "sag basins" on top of impermeable Sunnybrook diamict in the area of Sylvan Park (Fig. 3). Unfocussed seepage occurs where no sag basins are present (1); **D)** Head of scallop showing collapsed area over subsurface pipe

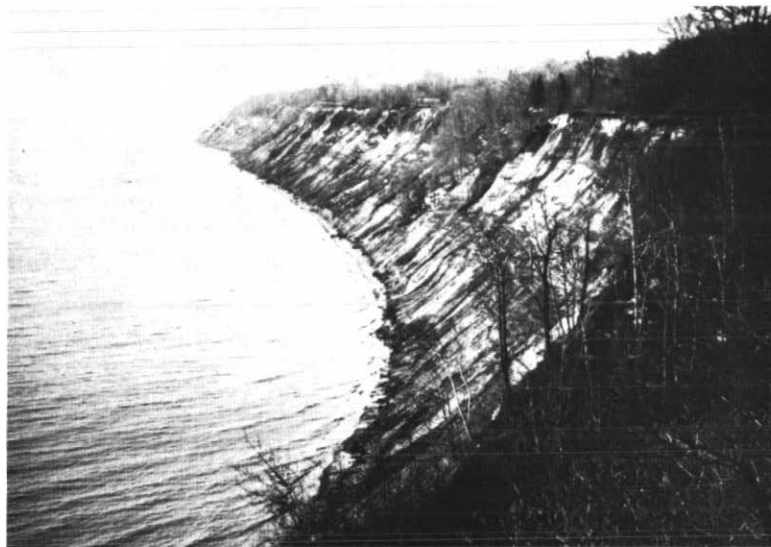
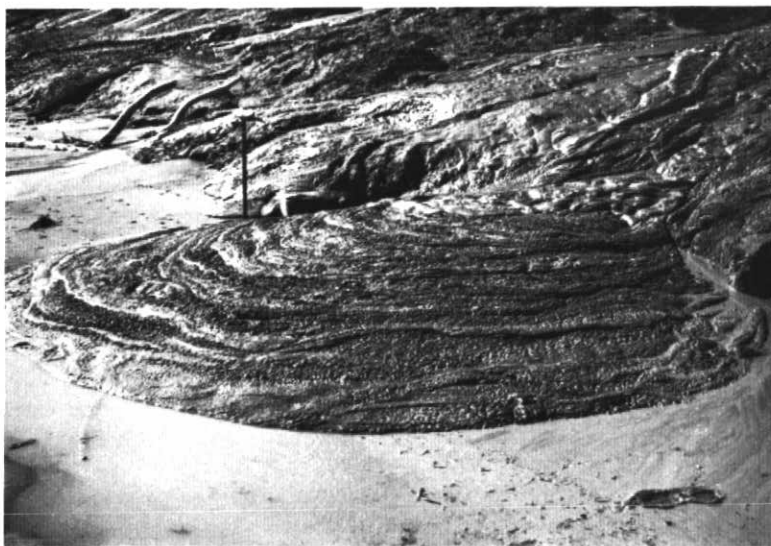
**Figure 11** A) Planar slopes at time of maximum spring snow melt; mudflows are moving downslope and have covered the beach area (B). Thaw of frozen bluff sediments allows high porewater pressures, built up behind the frozen face, to be dissipated thereby releasing water and generating mudflow activity. Note oblique wave approach to the coast which is responsible for littoral drift system (Fig. 2)
