Geology of Parliament Buildings 3. Building Stones of Ontario's Provincial Parliament Building

E. B. Freeman

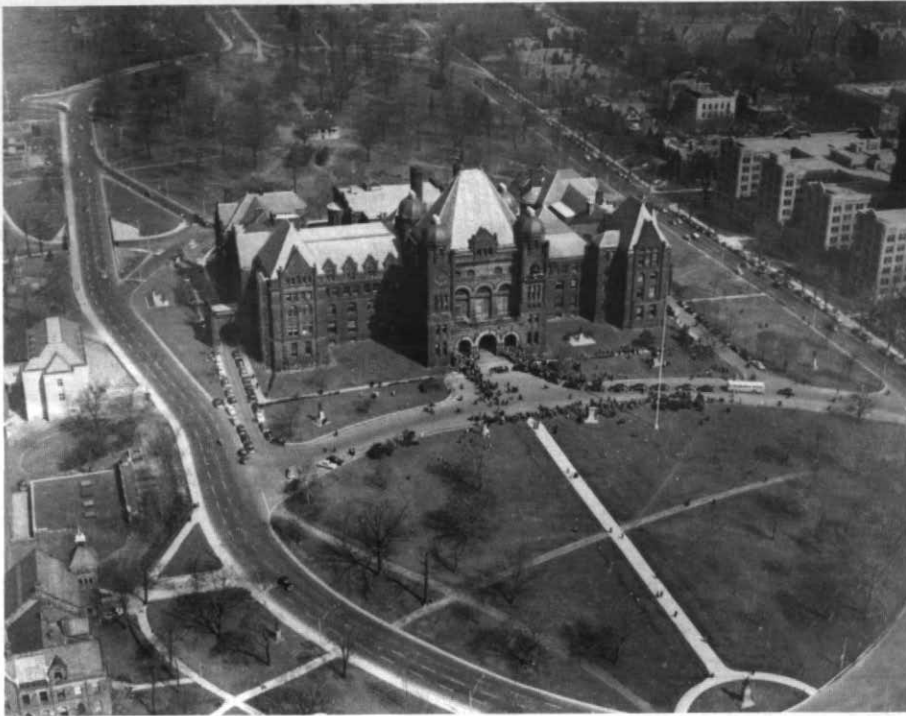
Figure 10 View of Queens Park looking north showing the fourth floor and dormers added by E.J. Lennox to the West Wing of the Parliament Buildings. This addition temporarily met the need for extra office space, but altered the former roofline symmetry of the building. (Toronto Reference Library, T 12055).

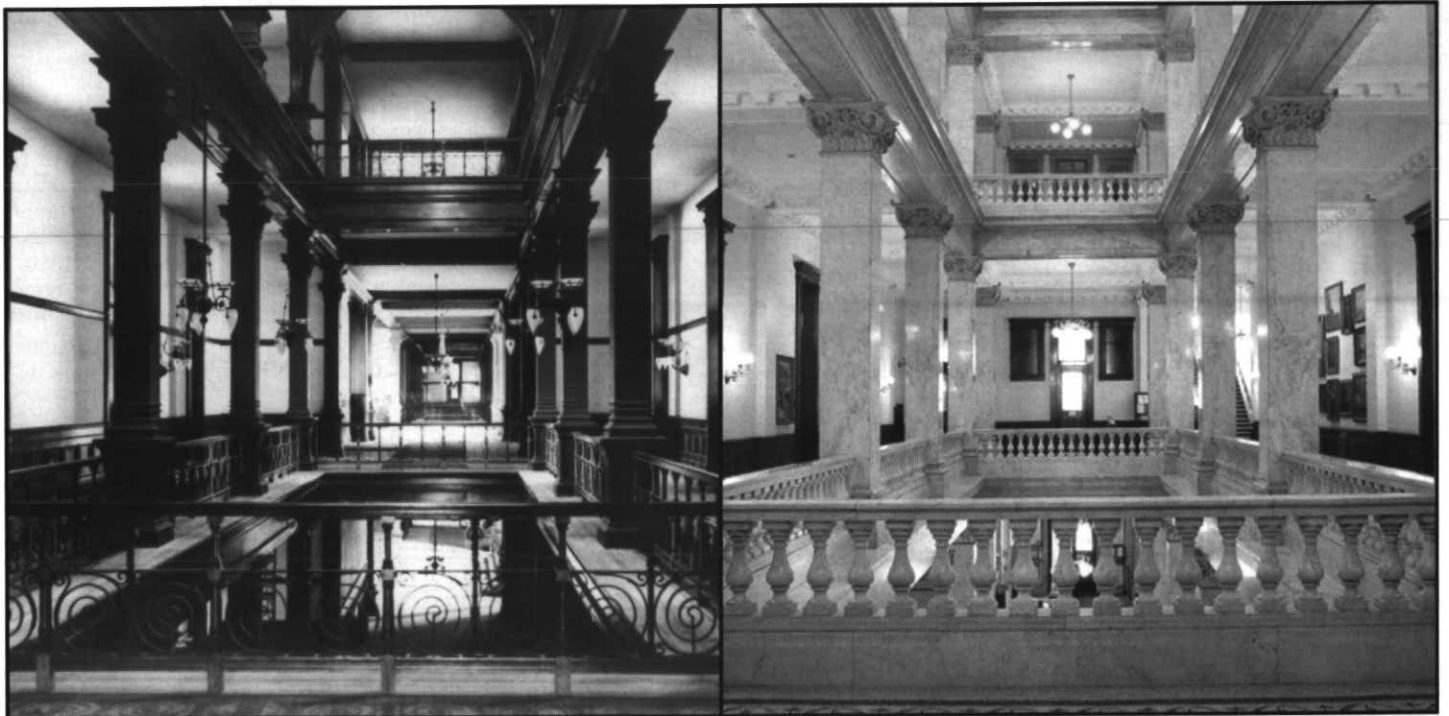
Figure 11 Wood floors, iron railings, and wood trim as seen in the left photo (City of Toronto Archives, Fonds 1244, Item 3003A) were replaced with concrete and marble floors of tesserae, and marble trim as seen in the photo on the right (Legislative Assembly of Ontario).

SC 48, box 3). Lennox ultimately increased the height of the West Wing by 162 cm to incorporate a fifth floor, and added a fourth floor and dormers along with a decorative skylight in the connecting pavilion to meet the demand for more office space. These changes altered the symmetry of the original design at the top, but after the fire, Lennox rebuilt the front façade of the West Wing with a set of paired windows similar to those of the East Wing to enhance the symmetry at the bottom. (Fig. 10). On September 1, 1909, workmen repairing the roof of the West Wing inadvertently started a disastrous fire that destroyed much of the wing including the library. Lennox was given the task of repairing the fire damage in addition to his contract to enlarge the West Wing. His specifications detailed replacing much that was wood in the original with terra cotta structural tile, steel, concrete and marble (Fig. 11).

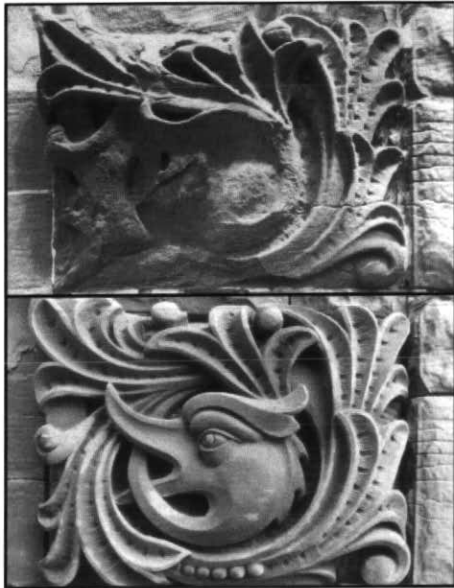
Figure 15 Before and after repair. Stonecarver Lawrence Voaides, created in Red St. Bees sandstone, the form of carving interpreted from that in the weathered Sackville sandstone

Stones used for repair or replacement included a small amount of *Credit Valley* for the balusters in the Legislative Chamber balcony, and *Red St. Bees* from sea cliffs near Cumbria, England, a stone much shipped to the US in the 18th and 19th centuries, for carved blocks and dutchman repair. Its mineralogy and competency is described in Hawkins and McConnell (1991). *Plumpton Red Lazonby* quarried from Lazonby Fell, 3 miles north of Penrith, England, a medium-grained high quartz sandstone very resistant to abrasion and weathering so was used for the north entrance steps and rampways. *Hulberton* sandstone from near Clarendon, NY was used for the large slabs required for the front entrance steps (331 x 166 x 14 cm).
