Active Earth: The Development of Big Slide, near Quesnel, British Columbia, between 1953 and 1982

Stephen G. Evans

Volume 9, Number 4, December 1982

The Development of Big Slide, near Quesnel, British Columbia, between 1953 and 1982.

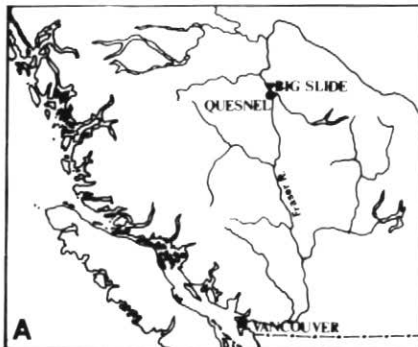
Figure 1A: Location of Big Slide within Fraser River system.

Big Slide is an extensive landslide complex on the east side of the Fraser River at the Big Bend, Moose Heights, 11.7 km north of Quesnel, British Columbia (Fig. 1). Aerial photographs dating from 1953, and field observations since 1973, show rapid landscape changes due to retrogressive slope movements. Changes are noticeable on a month to month basis and farmers in the vicinity mention the

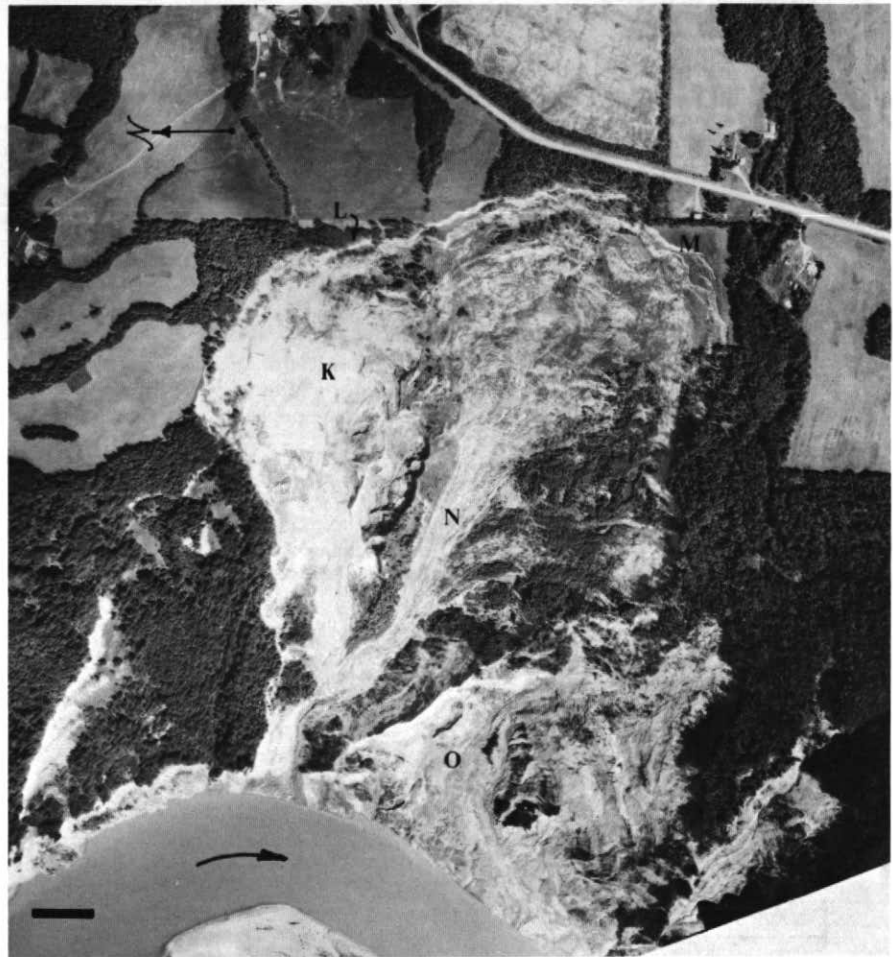
Figure 3: 1981 Air Photograph. K = North Bowl re-activated completely. Note broken ground. L = Active retrogression at North Bowl headscarp into in-situ glacio-lacustrine clay. M = Active retrogression at South Bowl headscarp has almost eliminated field (F in Fig. 2A). N =

Mudflow in South Gully. O = Extensive movements in landslide south of Big Slide. Note impingement of debris on Fraser River channel. Bar Scale = 100 m. Arrow denotes flow direction of Fraser River. (B.C. Air Photograph 81093-181).
