Geology of the Parliament Buildings 5: Geology of the Manitoba Legislative Building

W. C. Brisbin, Graham Young and Jeff Young

Volume 32, Number 4, December 2005

SUMMARY

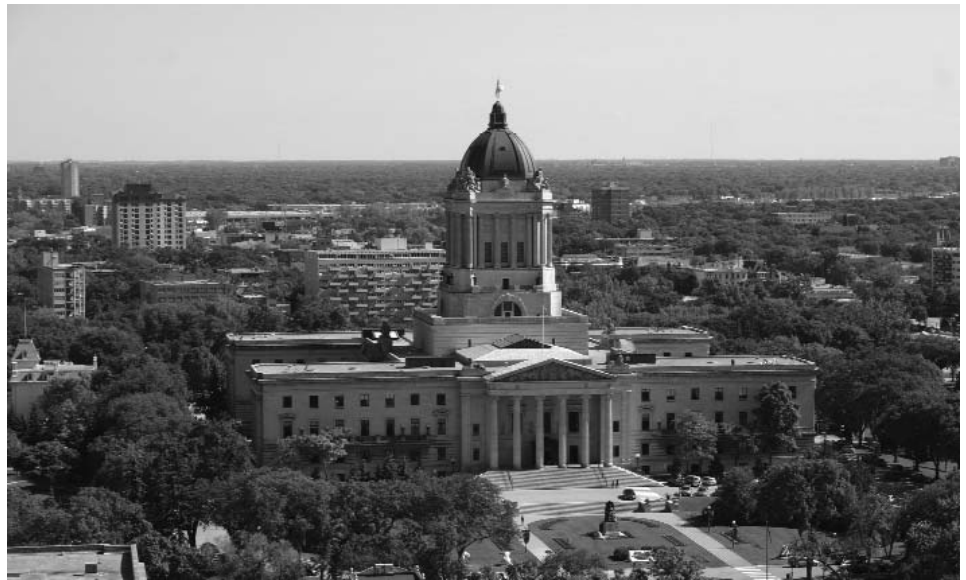
Figure 4. The Manitoba Legislative Building viewed from the north in spring 2005. Visitors are greeted at the front entrance by six ionic columns capped with a pediment symbolizing Canada. A sculpture of Queen Victoria, seen on the front lawn of the building, is one of many sculptures on the grounds. The refurbished Golden Boy atop the building symbolizes Manitoba's eternal youth and progress. Government House, the residence of the Lieutenant-Governor of Manitoba, is located on the left side of the photograph.

By February 1920, the new Legislative Building was completed. It was dedicated July 15, 1920, on the fiftieth Anniversary of the province. Figure 4 is a current view of the front of the building.

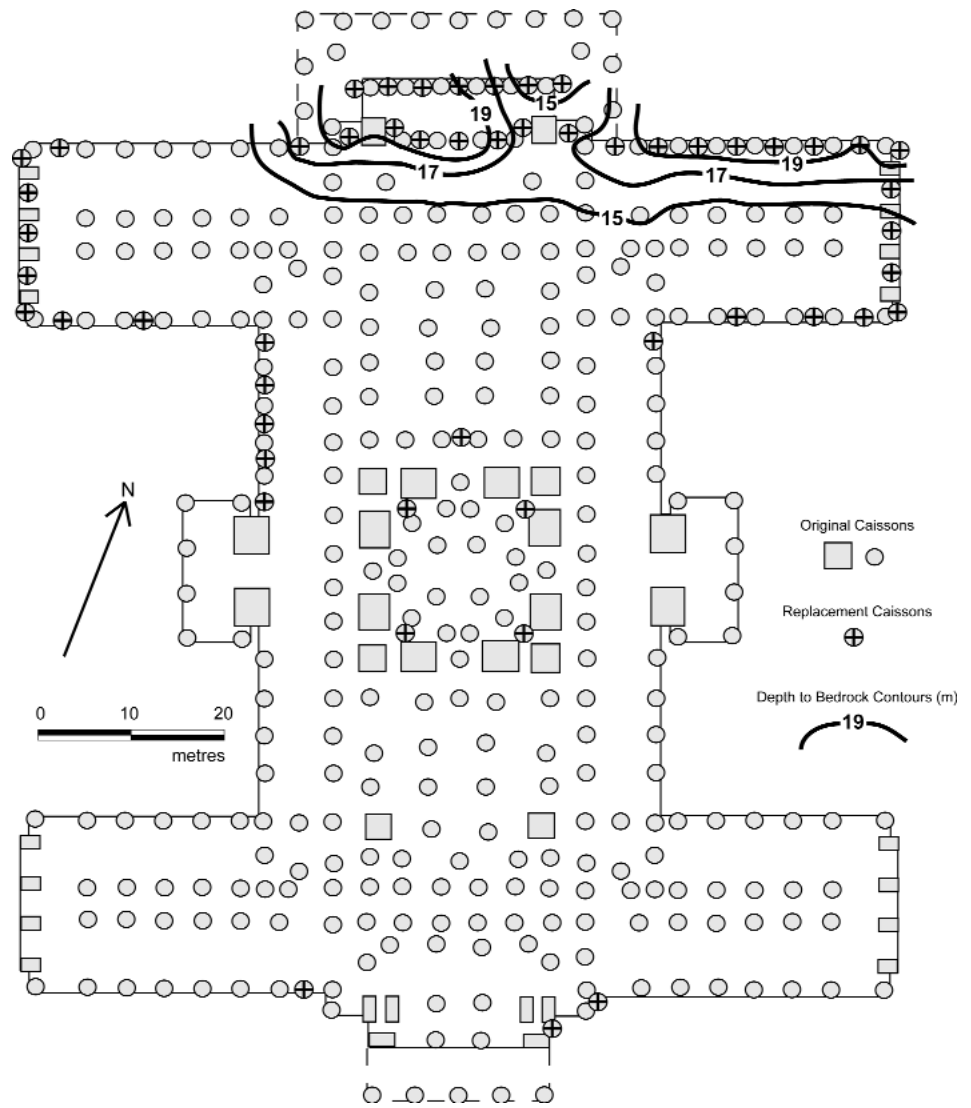
Figure 5. Plan and location of caissons, Manitoba Legislative Building (AM, GR3085 G8107, Item 545). The Legislative Building rests on 421 caissons, 369 of which are original caissons, and 52 of which replaced original caissons of poor quality. Caissons on this figure are to scale. The building is outlined by a thin solid line, except under the stairways at the north and south entrances, where the outline is dashed. The depth to the bedrock surface, measured from the top of the steel grillage that rests on the caissons, has been contoured using a contour interval of 2 m. Depth values under the southern part of the building are between 14 and 15 m; consequently no contours are shown. Beneath the north entrance, contour lines have not been extended under the stairways because the depths to bedrock are poorly constrained.

frame resting on the caissons (i.e., grillage), except under the north part of the building where it occurs at 14 to 20 m (Fig. 5). Bedrock relief in the northeast wing and under the north portico defines abrupt depressions that drop up to several metres (AM, GR 3085 G8106, Item 196, AM, GR 1609 G8014, File 3 Item 2). These depressions in the bedrock surface are consistent with paleokarst features underlying Winnipeg (Baracos and Kingerski, 1998).

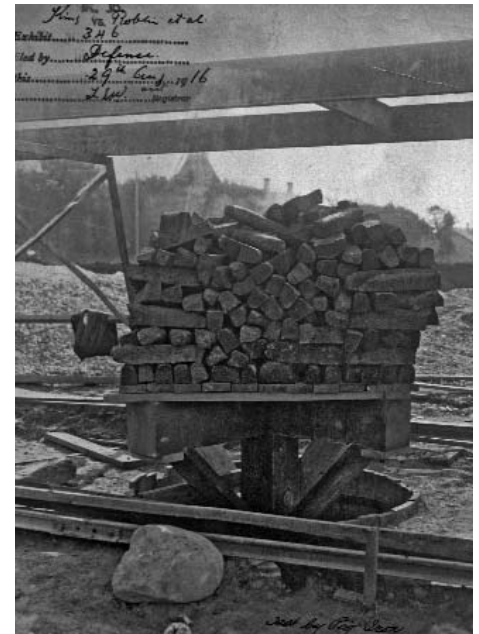
Figure 6. Loaded platform for the bearing test on indurated till in the excavation for caisson 39, located adjacent the north portico along the northeast wing (AM, GR3085 G8101, Item 28). The test was done using a progressively loaded platform, 1.68 m square, that was erected on a 3 x 3.6 m rectangular mast extending to indurated till (AM, GR3085 G8100, Item 6). An initial 5 tons of pig iron was placed on the mast and 22 mm of settlement occurred after 3.5 hours. Another 10 tons of pig iron were added at intervals over the next 24 hours. A total of 26 mm of settlement was measured during the 44 hours of the test. Upon removal of the load 6 mm of rebound was measured. Wood cribbing and metal rings support the wall of the caisson excavation.

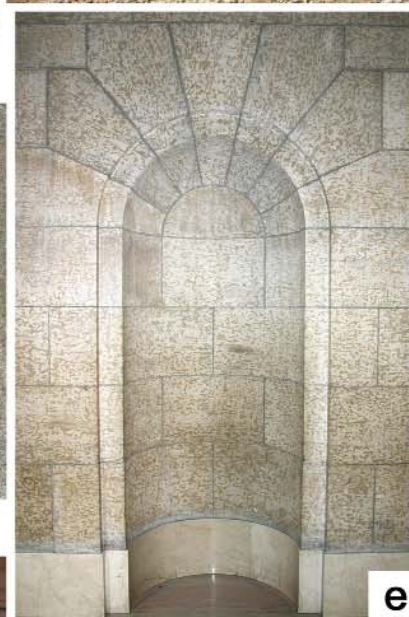
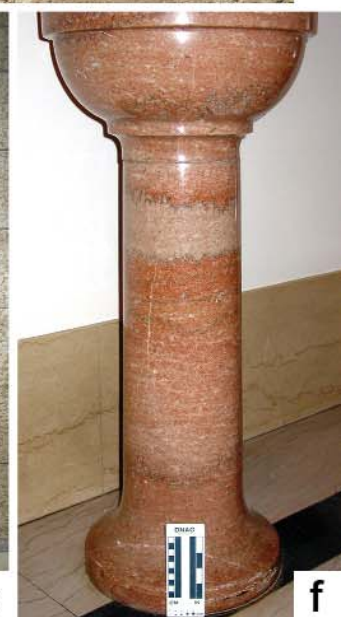
Figure 7. (*Opposite page*) Building stones and their usage in the Manitoba Legislative Building. 7a) Exterior view of east side of the building; walls and plinth are Tyndall Stone, statue is Bedford limestone, and steps are Butler granite. 7b) Bedford limestone of exterior statue showing weathering relief and details of ooid and fossil grains. 7c) Tyndall Stone; detail of exterior stone showing differential weathering between pale buff limestone and darker dolostone burrow mottles; note abundant crinoid grains, particularly in the limestone. 7d) Butler granite, gneissic type. Slab is 1.22 m wide. 7e) Tyndall Stone alcove, second level interior hallway. Tyndall Stone in the walls is oriented parallel to original bedding, except in the keystones of the arch where the stone has been rotated so that bedding is in a radial position; baseboards are of Botticino marble. 7f) Drinking fountain carved from pink-red Tennessee marble shows the characteristic layer-parallel stylolites; the floor is of Tennessee marble and Ordovician black marble, and the baseboard is Botticino marble. 7g) Decorative use of marbles in the rotunda at the top of the Grand Staircase. The carved balustrade encircling the opening to the Pool of the Black Star is Botticino marble; the floor includes grey-pink Tennessee marble, Ordovician black marble, and green Vermont Verde Antique marble. 7h) Marble floor on the main level of the Grand Staircase Hall is composed of pink and grey-pink shades of Tennessee marble, Ordovician black marble, and green Vermont Verde Antique marble.

Tyndall Stone is a grey to buff, mottled, fossiliferous, dolomitic limestone that is quarried at Garson, Manitoba, 37 km northeast of Winnipeg. It belongs to the Late Ordovician (Maysvillian – Richmondian; Elias, 1991) Selkirk Member of the Red River Formation. This stone gives many parts of the Legislative Building its characteristic appearance and is used for exterior walls, columns, bases of pediments, bases of statuary, and the fountain in the south grounds. In the interior it can be seen in walls, columns, the main stairway and gallery balustrades, and some sculptured forms (Figs. 7e, 8a).

The mottles that give Tyndall Stone its characteristic appearance (Fig. 7c) are generally considered to be burrows made by organisms moving through the muds of a soft ancient seafloor (Kendall, 1977). The large burrows that form the mottles are assigned to the ichnogenus *Thalassinoides*; these were probably produced by arthropods (Kendall, 1977; Coniglio, 1999). Within these large burrows can be seen smaller burrows that have distinct outlines. These were made by organisms, possibly polychaete worms, which mined the original burrow fills for nutrients (Kendall, 1977).

sions in the corridor drinking fountains (Fig. 7f). Stairwell landings reveal unusual structures related to the intersections of the two orientations of stylolites. The origin of these features appears to have involved irregular dissolution and disturbance of bedding, but otherwise is considered problematic.

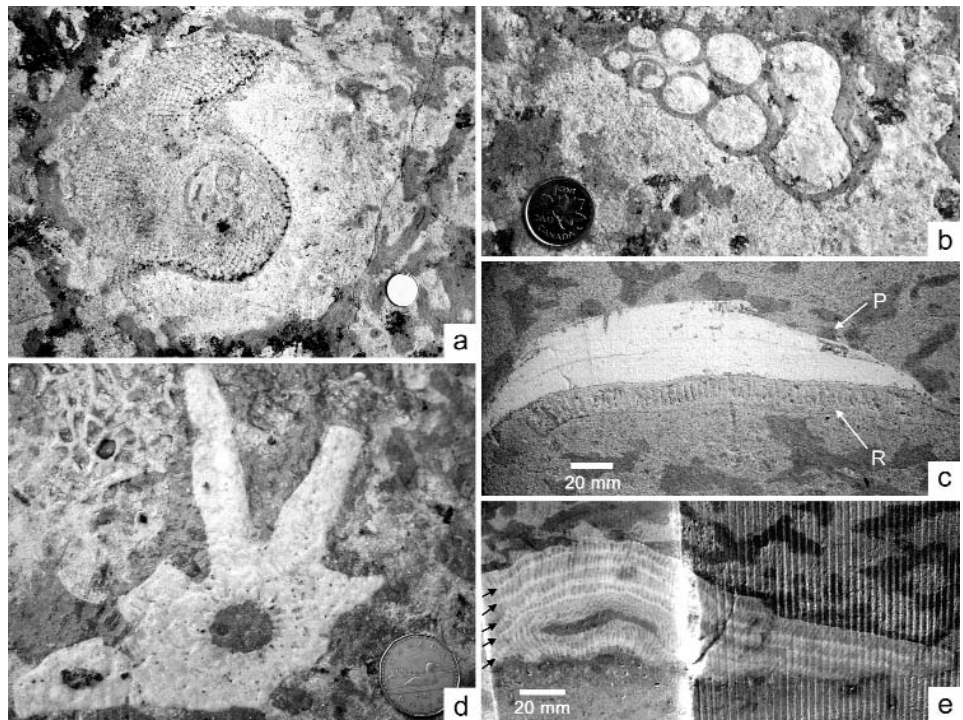
Figure 9. Examples of the diverse fossils in Tyndall Stone at the Manitoba Legislative building; a to d are on exterior surfaces; e is at the top of the Grand Staircase. 9a) Receptaculitid *Fisherites*, transverse section; coin diameter is 19 mm. 9b) High-spired gastropod (snail); coin diameter is 19 mm. 9c) Vertical section of receptaculitid (R) encrusted by tabulate coral *Protrochiscolithus* (P). 9d) Sponge (lower centre), with the chain tabulate coral *Manipora* (upper left); coin diameter is 26 mm. 9e) Vertical section through colony of the rugose coral *Crenulites*, showing distinct cyclic banding that probably represents annual growth bands (arrowed).

The most common Tyndall Stone macrofossils are receptaculitids, an extinct group of uncertain affinities, possibly calcareous green algae (Wong, 2002; Figs. 9a, c). The second most abundant group is the solitary rugose corals (horn corals). Other common fossils include stromatoporoid sponges, colonial rugose and tabulate corals, bra-

chiopods, bryozoans, gastropods, cephalopods, and trilobites (Figs. 9b-e). The most abundant bioclasts in Tyndall Stone are sections of echinoderms. These can be readily observed on the outside of the Legislative Building, where grains are more visible as a result of weathering (Fig. 7c). Complete echinoderms are very rare because their skeletons were readily broken up after death.

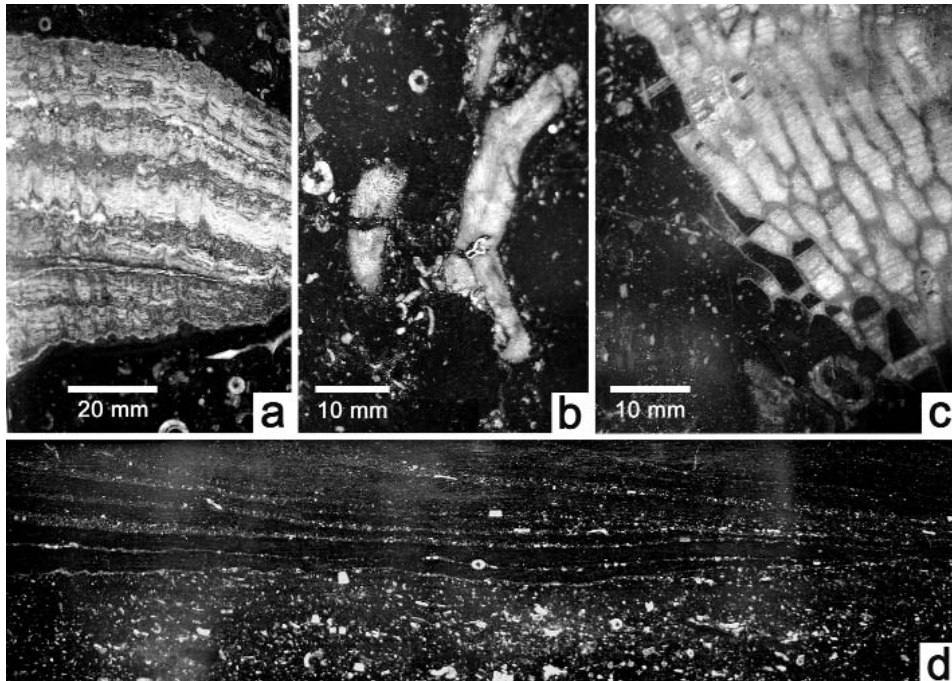
Figure 10. Examples of fossils and structures in Ordovician black marble in the Legislative Chamber. 10a) Stromatoporoid sponge, vertical section. 10b) Branching bryozoans associated with echinoderm debris. 10c) Colonial coral *Foerstephyllum* sp., oblique vertical section. 10d) Vertical section of cross-laminated limestone, with abundant echinoderm (crinoid) debris.

In the black marble, the most abundant fossils are crinoid stem segments, but there are also brachiopods, bryozoans, stromatoporoids, cephalopods, gastropods, and corals (Fig. 10a-d). These are similar to forms found in the Crown Point Formation and other Chazy units. The fossil assemblage includes stromatoporoids similar to the Crown Point Formation's *Labechia* and *Pachystylostroma* (Kapp and Stearn, 1975), and examples of the coral genus *Foerstephyllum* consistent with *F. wissleri* (Welby, 1961), which occurs in blue-black limestones of the Crown Point Formation in the Lake Champlain area. Nevertheless, we have not been able to identify the most characteristic Crown Point fossil, the gastropod *Maclurites magnus* (Oxley and Kay, 1959). Consequently the Legislative Building stone could have been derived from
