Slope Stability and Land Use in Mountain Valleys

Volume 9, numéro 1, march 1982

G. H. Eisbacher
Geological Survey of Canada
 100 West Pender Street
 Vancouver, B.C. V6B 1R8

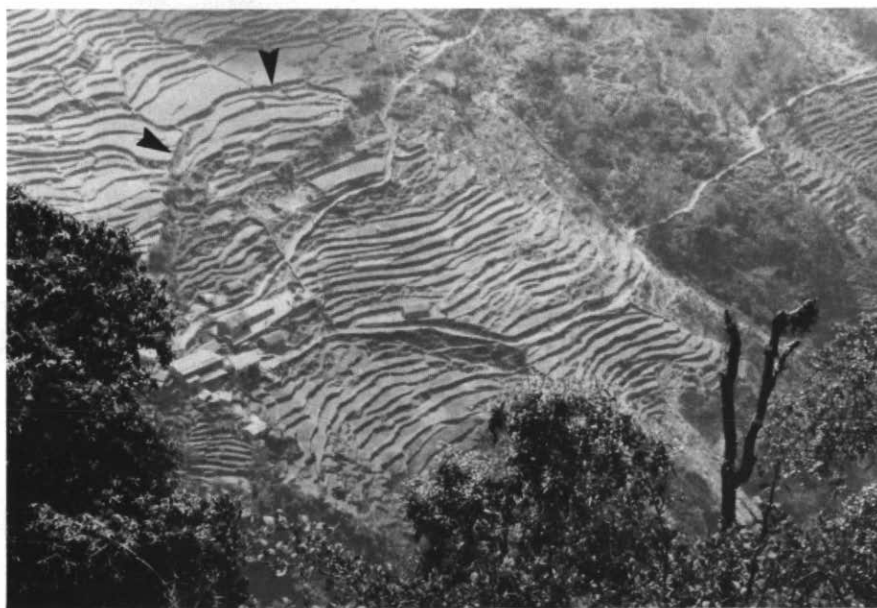
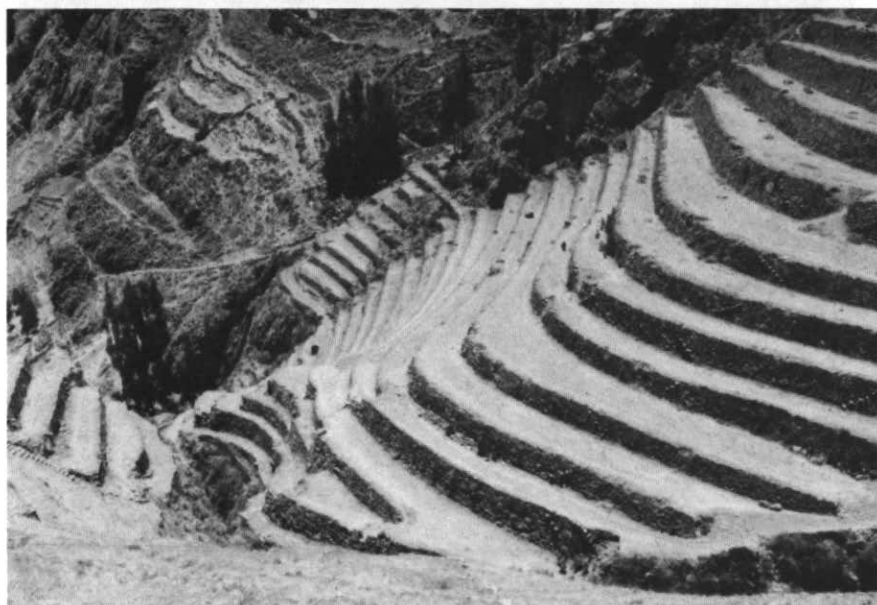
Figure 1 Agricultural terracing for intense use of steep mountain slopes. Top: Terraces for the cultivation of rice on a deeply weathered slope near Ulleri, Nepal Himalayas; the berms retaining the water during the monsoon season are composed of stony soil and have to be carefully maintained to avoid gullying and debris slumping; note that the buildings and the trails are located on a large incipient slope failure

that can be recognized by the distinct downward-concave headscarp above the upper trail (arrow); morphology and vegetation on the right of this area suggest a previous slope failure. Bottom: Agricultural terraces constructed within the domain of the fortified Inca settlement of Pisac, Peruvian Andes; meticulously laid out retaining walls of stone and runoff ditches have survived 400 years of neglect.

In spite of the natural limitations imposed by sloping terrain, mountains have always provided food, shelter, minerals, and energy - provided that the physical limitations of the environment were understood. Indeed, inaccessibility and rugged setting have permitted the survival of unique cultural patterns in the face of changing political currents. The terrace cultures of Asia and pre-Hispanic America demonstrate particularly well to what extent sloping land can be improved to serve human needs (Fig. 1).

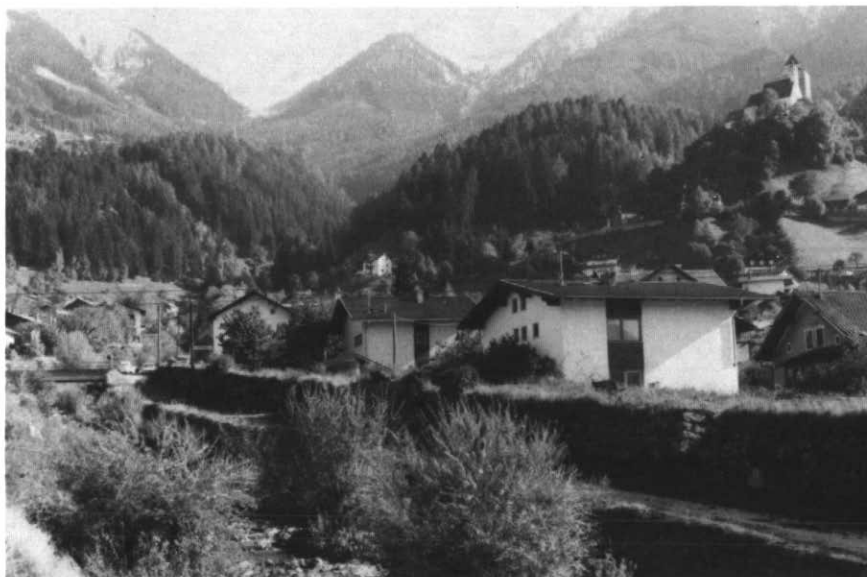
Figure 4 Elevated channel across the fan of a formerly notorious torrent that used to ravage the Medieval mining town of Schwaz, Austria. In this century, the upland debris sources have been brought under control by reforestation, check dams, and snow-avalanche fences; in

addition, two protective dams above the fan apex provide for a safe setting of the built-over debris cone: thus modern homes (on the right) have been erected directly on the elevated flanks of the old stone masonry dams.

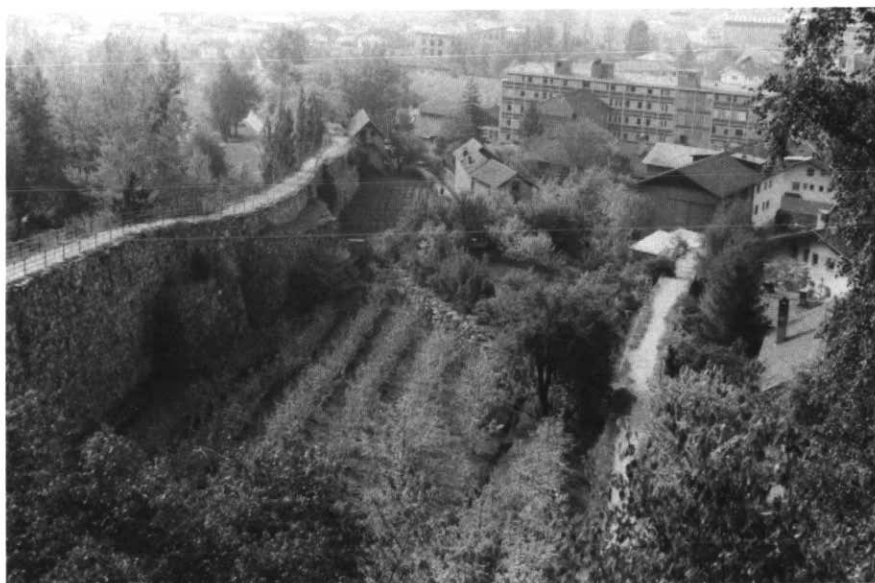
Figure 5 Two generations of protective debris-diversion dams at Schlanders, Italy. The older dam (on the right) was breached and practically buried during a debris flow catastrophe in 1731. A larger dam which eventually reached a length of 300 metres and a height of 10 metres (on the left) has served its purpose well since

1760. Due to accretion behind the dam the channel of the torrent (located on the left of the photo) now is 5 metres above the level of the adjacent cone. Orchards in the foreground and modern hospital building in the background rest on thick debris lobes deposited in 1731.

Deflection dams and walls, much used in the past (Fig. 5), are applied where a sector of the fan can be set aside to accommodate excessive flows. Deflection structures increase in efficiency if the sector set aside for debris accumulation is lowered by excavation to provide additional space in the form of a debris

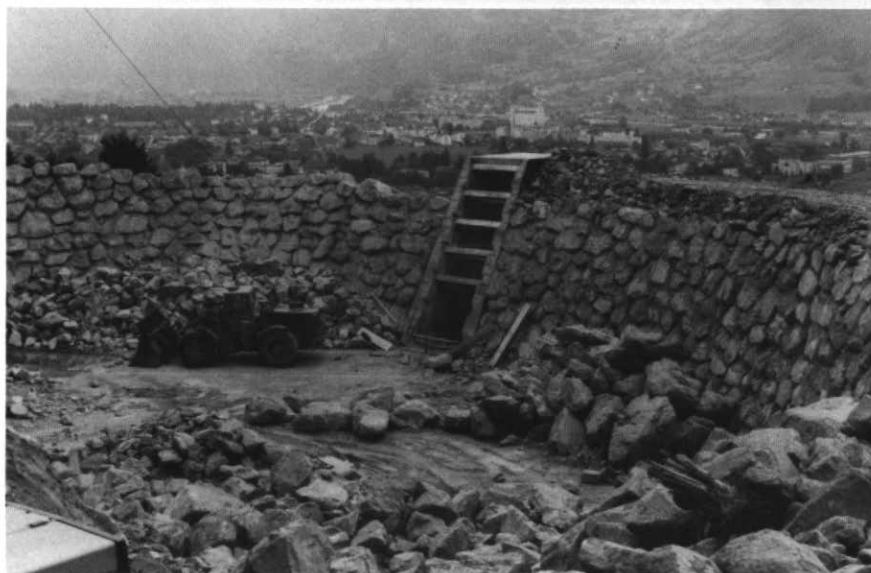
Figure 6 Two examples of transverse protective dams. Above: Semi-circular protective dam with massive uphill-facing stone block armour and a selective discharge section, designed against rock fall - debris avalanches near Alt-

dorf, Switzerland. Below: Transverse protective dam with steel-concrete wings, masonry armour, and selective discharge section of steelbeams, designed against debris flows; location above the village of Flaurling, Austria.

Transverse protective dams, in recent years, have developed into sophisticated structures involving rough blockwork, stone masonry, concrete, and steel beams in a combined design (Fig. 6). Retention capacity and strength of such structures in general provide against design flows of up to 300,000 m³ in volume and impact forces of blocks several metres in diameter. The selective discharge section of steel or concrete bars, strong enough to contain destructive flows, allows the passage of normal bedload and thus avoids premature aggradation behind the structure. Revetments and masonry walls along the torrent channel below the protective dam guide bedload material or small debris flows into the receiving river. The area immediately above a transverse dam can also be excavated to permit greater debris retention.

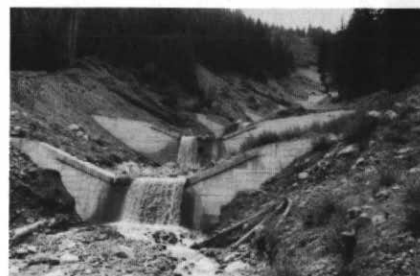
Figure 7 New check-dams along a deeply scoured source area of residual colluvium near Inzing, Austria. These dams, arranged in a stacked pattern, confine the torrent to a central line and create a more balanced profile, thus preventing erosional instabilities along the embankments. Note the gently rising stone carapaces on either side of the discharge section of the check-dams; they are designed to accommodate the passage of small debris flows without endangering the lateral abutments.

Control works (check dams, drainage, retaining walls) are used to stabilize erosional scars on colluvial slopes in the source area. Check dams are transverse stone-masonry or concrete structures *without* direct protective function. They serve, particularly in stacked arrays, to create a stepped longitudinal profile through a potentially dangerous debris source (Fig. 7). Aggradation behind the

dams adds stability to the toe of upstream embankments; the rising wings, merging with the topography of the flanking slopes, force the flow of the torrent to the centre of the channel. A gently concave discharge section should accommodate small debris flows by avoiding stresses in the abutments. The main function of check dams therefore is to neutralize the erosional forces of the torrent on its banks and reduce the chance of blockages during abnormal runoff. The principles of check dam design were first clearly expressed by the Tyrolean engineer Duile (1834) in a pioneering monograph. The technique of source area control by check dams has found wide application throughout the Alps, Japan, and elsewhere. Check dams have tranquilized many a torrent noted for its notorious debris flow activity, particularly if their emplacement was accompanied by the design of appropriate drainage works, retaining walls, and revegetation of erosional scars.

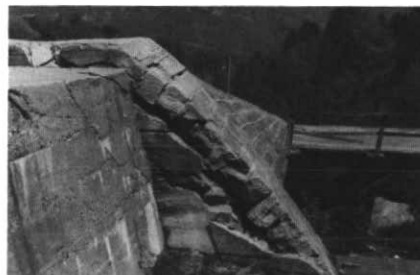
Figure 8 Wing of a check-dam, being slowly crushed by lateral pressure resulting from deepseated creep along unstable flanks of a torrent channel near Crodo, Italy.

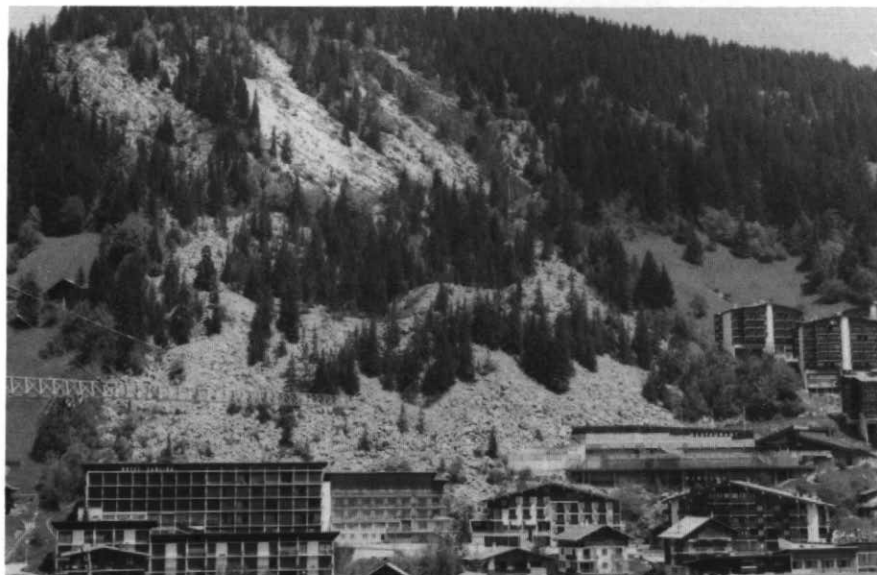
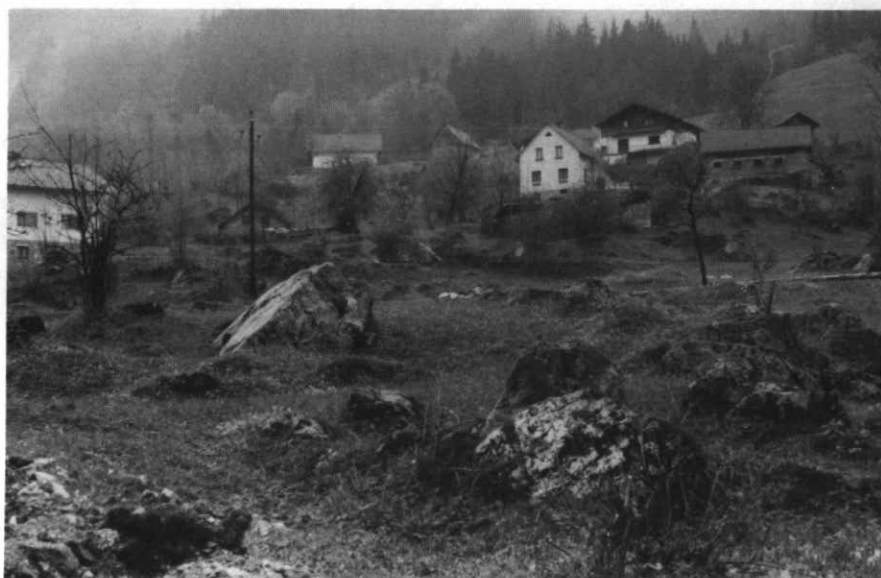
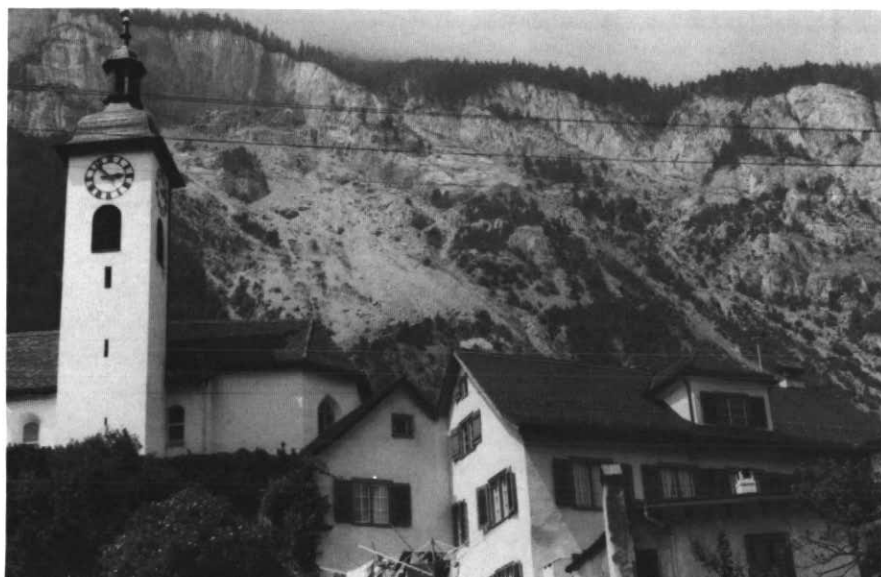
Figure 10 Three examples of built-over rock avalanche deposits in the Alps. Shown at the top is the modern ski village of Clusaz, France, which is in the process of growing around a (prehistoric?) rock avalanche deposit that is the result of a dip-slope failure in well-bedded carbonate rocks. Shown at the centre are the built-over deposits of a rock avalanche which resulted from the failure of a scarp-face of carbonate rocks that buried the mining town of Radmer a.d. Hasel, Austria, in 1540. Shown at the bottom is the town of Alt-Felsberg, Switzerland, whose church rests on a slab of a prehistoric rock fall from the dip-slope of carbonate rocks behind the settlement; a period of serious rock fall activity in the middle of the nineteenth century prompted an effort to relocate the town to a new site called Neu-Felsberg; today both Alt-Felsberg and Neu-Felsberg continue to expand below the cliff.

ing which major climatic or seismic parameters may change. In the Alps, many prehistoric and historic landslide deposits have been built over (Fig. 10) and the risk of possible recurrent failure along adjacent cliffs seems to have been widely accepted (Eisbacher, in prep.). However, even in the most densely populated mountain valleys of the Alps, some rock avalanche deposits are being approached only up to a *respectful distance* because of poor building conditions, fear, superstition, and tradition. Many rubbly surfaces that owe their origin to rock avalanches or large debris flows have legends attached to them that tell of disappeared towns, raging giants, and infuriated dragons. (e.g., Dalla Torre, 1913).

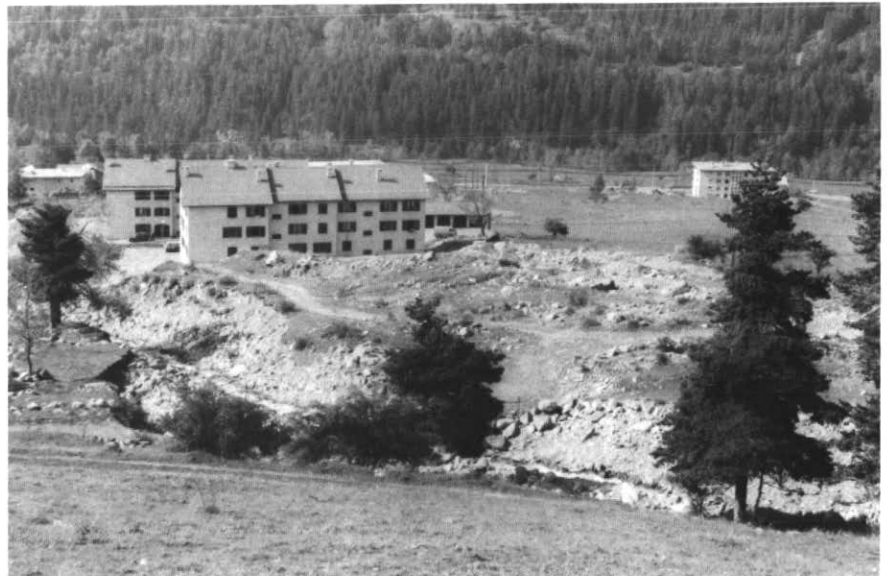
Figure 11 New apartment buildings located on blocky deposit of a historical debris flow near Briançon, France. In recent decades the forest cover of the catchment area of this torrent has improved markedly over the state it was in at

the turn of the century, but whether or not the better forest cover of the uplands would impede debris flows during an extreme weather situation is difficult to say.

With regard to debris flows the appraisal has to include the cone *and* the catchment basin. The mapping of relative hazard on the cone is only possible where information is available on the rate of past debris flow recurrence and the location of preferred debris flow tracks. The analysis is based on historical records, wherever available, or on a variety of "hazard indicators" (the silent witnesses or 'Stumme Zeugen' of Aulitzky, 1973). The most important hazard indicators for areas on the debris cone are the size of blocks strewn about, number and thickness of debris layers, scarred tree trunks, channel-surface gradient, and lack of channel incision. Occasionally potential impact forces can be calculated from past damage to vegetation (Mears, 1977). In addition the conditions in the uplands have to be considered: erodibility of debris and incipient bedrock slumps across the torrent. Where debris fans are relicts from a geological period with entirely different climate - such as those in the dry interior parts of British Columbia - this method cannot be used. If, however, a torrent system can be shown to be dormant or active the evidence of recurrent mass movements of the past can be used to extrapolate the potential behaviour of the system into the future - still a difficult task. The analysis assumes minimal long-range environmental changes (e.g., climate, forest cover, seismicity, human activity) and in the end can never be more than semi-quantitative and somewhat subjective (Zeller, 1972). Nevertheless, there are cones whose suitability for permanent dwellings can be questioned (Fig. 11). In such cases building restrictions can be

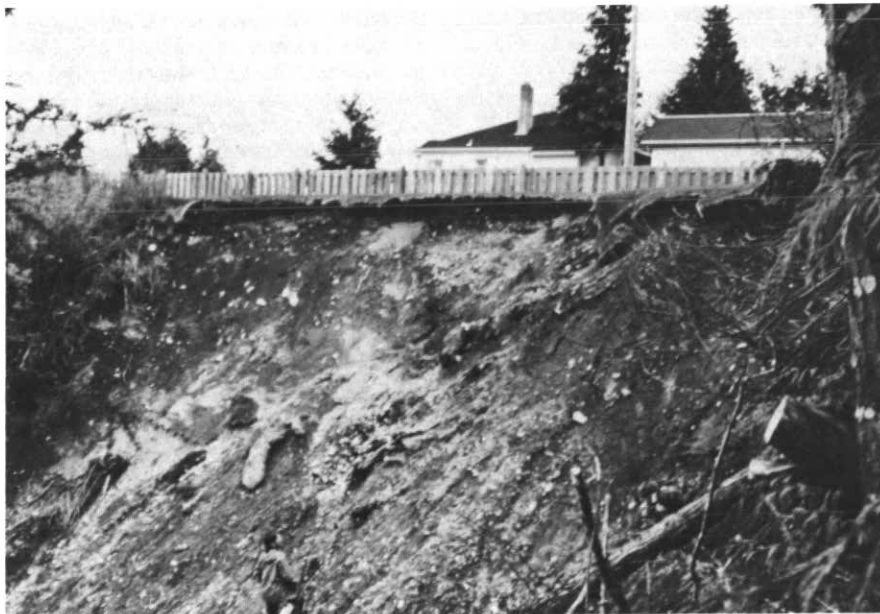
Figure 12 Shallow failure of surficial debris along a steep terrace rim along the eastern coast of Vancouver Island. Failure occurred during an intense rainstorm in December 1979.

along sand-gravel-till benches (as on the coast of British Columbia), lacustrine silt banks (as in the Interior of B.C.), or shale scarps (in the Cordilleran Foothills), are notorious for their instability. Traditionally they have been most desirable development land, because, as the saying goes, 'nobody can build in front of you'. Stabilization by retaining structures or deep foundations is often deemed too expensive or is opposed on environmental grounds. Thus geological processes continue to operate freely and soon a building may be the unwilling object of an otherwise fascinating demonstration of the principle of uniformitarianism (Fig. 12).

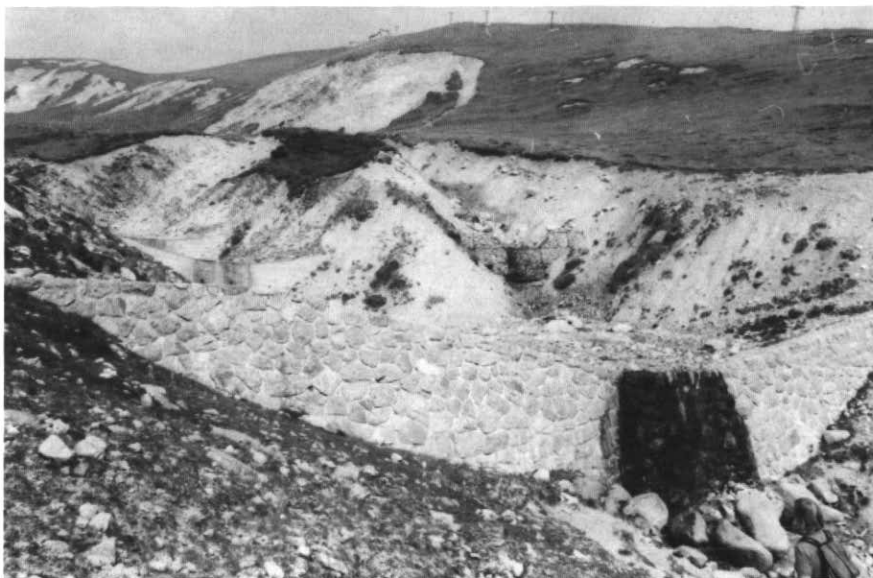
Figure 14 Ski slope on granitic colluvium near Meran, Italy. The alpine grass cover is scarred deeply by gullying and debris slumping. This type of deterioration of ski slopes is commonly set in motion by springtime snow creep and snow slides involving not only a tightly com-

pressed snowpack but also some of the underlying soil. Note the three types of check dams across the gully (concrete, gabion, masonry) for the purpose of counteracting depth erosion and embankment failures along the exposed noncohesive colluvial veneer.
