Active Earth: Landslide Terrain, Scatter River Valley, Northeastern British Columbia

Landslide Terrain, Scatter River Valley, Northeastern British Columbia

R.F. Gerath, Engineering Geologist
O. Hungr, Geotechnical Engineer
Thurber Consultants Ltd.
100-1281 West Georgia Street
Vancouver, B.C. V6E 3J7

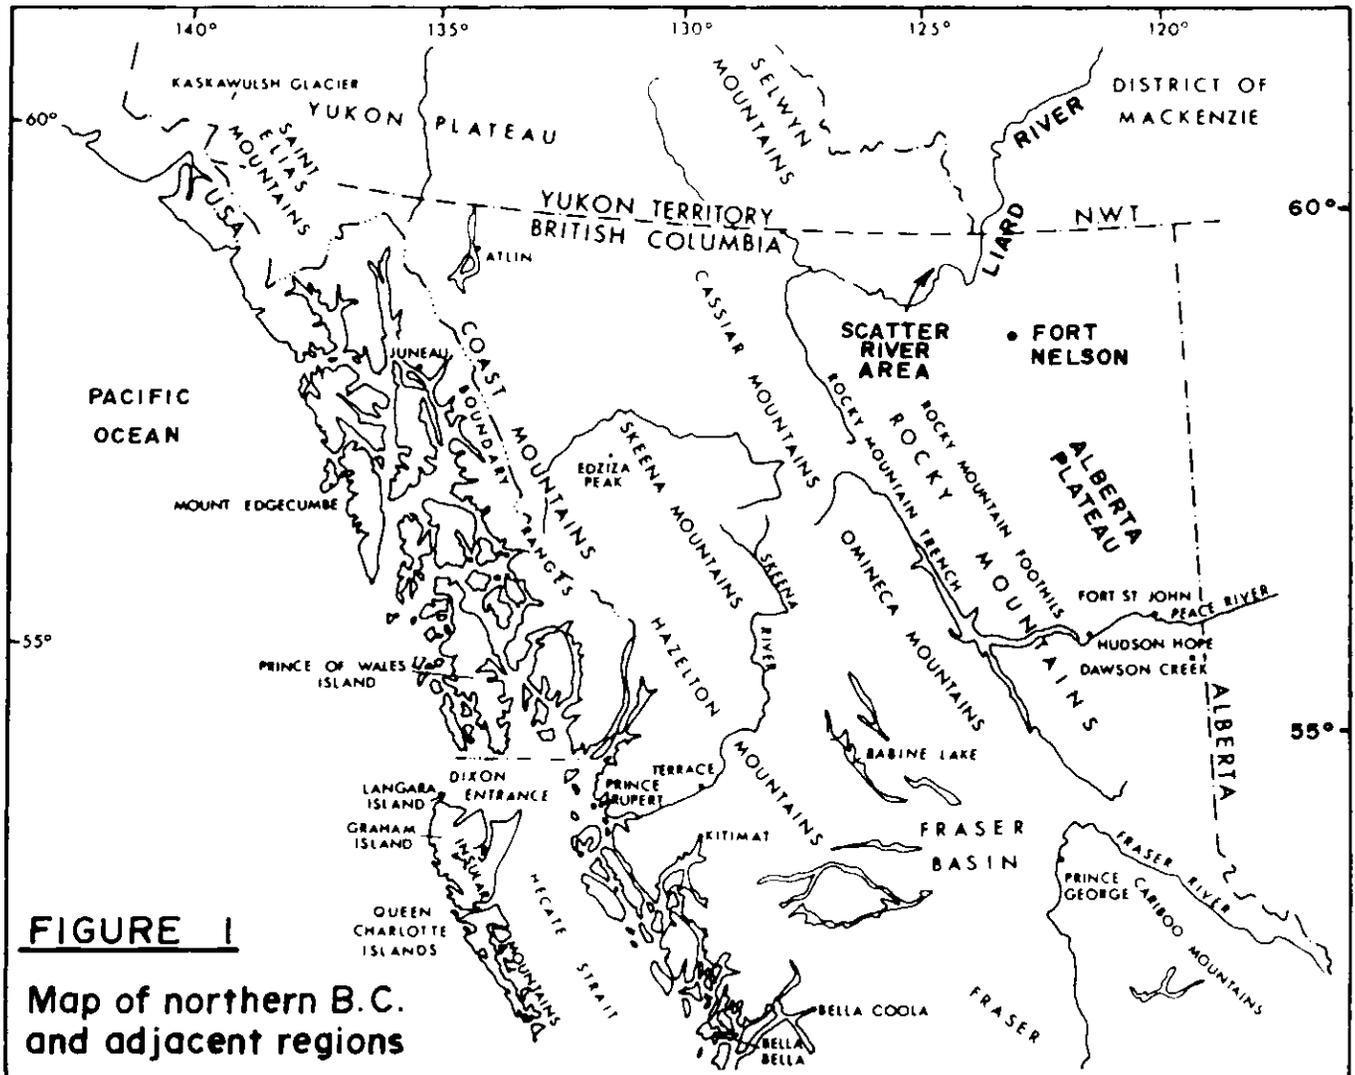
FIGURE 1

Map of northern B.C. and adjacent regions

(Fig. 1). The most extensive landslides have occurred along the canyon system of the Scatter River for the first 20 km upstream of its confluence with the Liard River (Fig. 2).

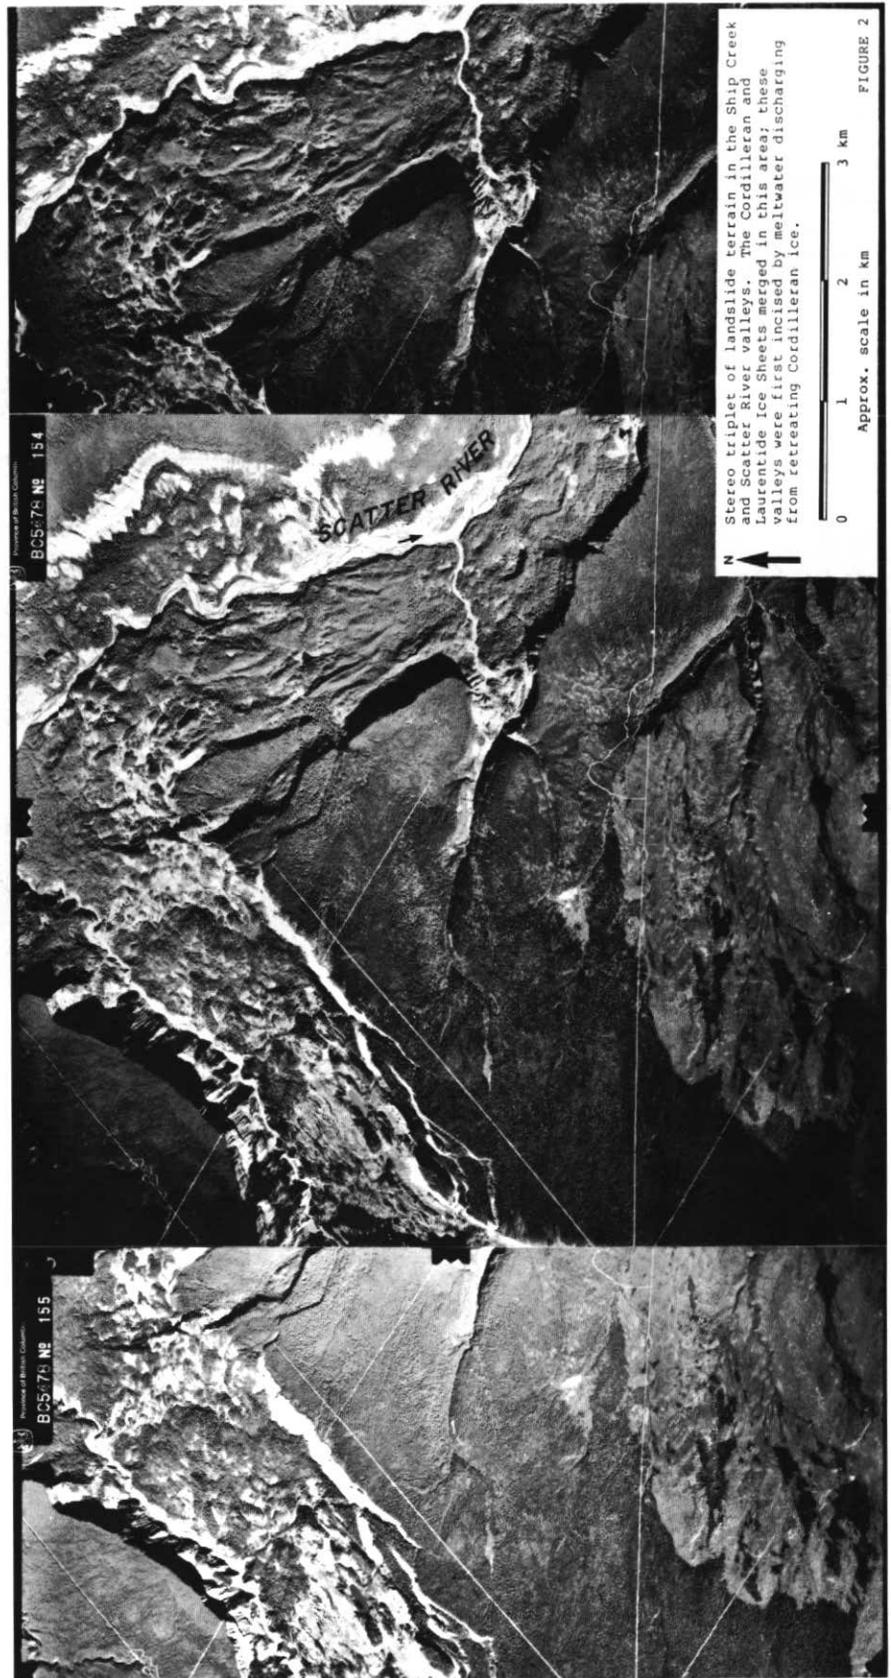
FIGURE 2

Figure 2 Stereo triplet of landslide terrain in the Ship Creek and Scatter River valleys. The Cordilleran and Laurentide Ice Sheets merged in

this area; these valleys were first incised by meltwater discharging from retreating Cordilleran ice.

The rims of the canyons, where the head regions of the sliding are located, exhibit very large extension features. One of the most prominent has been named by us the "Ship" (Fig. 3). This is a block of intact sandstone with a surface area of about 3 ha, which has moved away from the head scarp on a virtually horizontal sliding plane; behind this feature are two tiers of back-tilted graben blocks (Fig. 4). This area can be viewed stereoscopically near the left hand side of the central panel of Figure 2. Even larger back-tilted slide masses, with individual areas of over 15 ha, are visible on Figure 2 near the confluence of Ship Creek and the Scatter River. Most of the

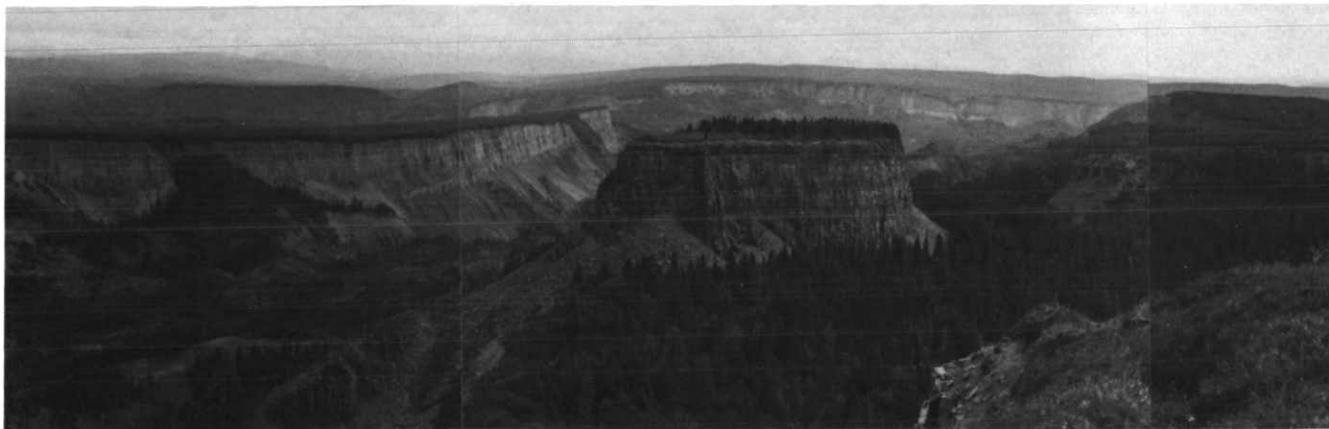
Figure 3 North-northeast view down the valley of Ship Creek towards the Scatter River. The concordant surface of this portion of the Alberta Plateau is formed by the Lower Cretaceous Bulwell member sandstone of the Scatter Formation.

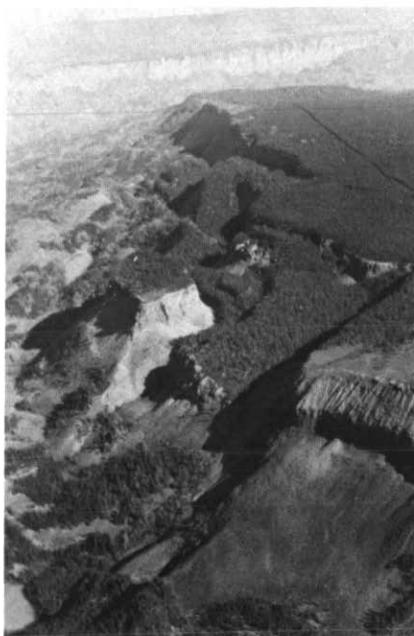
Figure 4 Oblique aerial view to the northeast along a 4 km sector of the south rim of Ship Creek valley. The Ship and its adjacent slumped sandstone masses are strikingly evident.

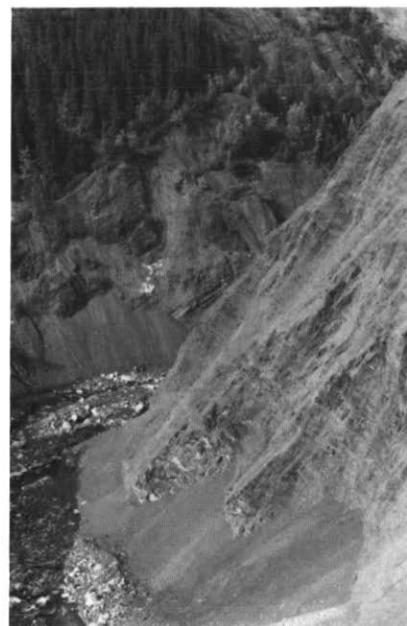
Figure 5 Back-tilted shale and siltstone strata of the Lower Cretaceous Garbutt Formation in a downstream view along Ship Creek. The beds on the right bank dip approximately 20° to the southeast; beds to the left dip at a similar angle in an opposite direction. Near-vertical beds striking parallel with the stream course have been observed on the channel floor nearby.

Other evidence of the extraordinary scale of these earth movements is found along the channel of Ship Creek. Some sections of the toe scarps expose more-or-less intact shale masses. These are invariably back-tilted at angles of 10° to 20° into the slope on both sides of the stream. This back-tilt persists in sectors where the stream has cut a meandering gorge, thus creating a surprising effect of staggered dips if one looks along the axis of the stream (Fig. 5). In the Scatter River and Ship Creek channels, several large bedrock exposures have been observed with vertical dips and strikes parallel to the stream. These are surprising structural observations in a region characterized by flat-lying strata. One interpretation is that the vertical beds are a part of a complex pressure zone where slide masses from the left and right meet and thrust against each other. Stream incision through this zone may permit the slide masses to move gradually together and thus facilitate further retrogression.
