## Geological Hazards and Disasters in St. John's

Liverman, D., Catto, N. & Batterson, M. (2006). Geological Hazards and Disasters in St. John's. *Newfoundland Studies*, 21(1), 71–96.

DAVID LIVERMAN, NORM CATTO,  
and MARTIN BATTERSON

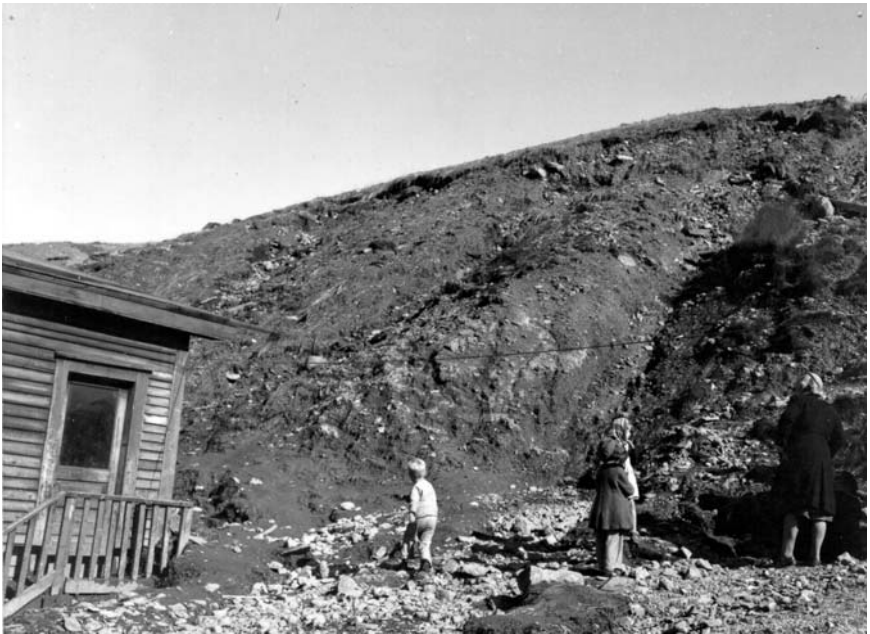
*Figure 3. The scar left by the landslide of 15 September 1948 at 387 Southside Road (St. John's City Archives, used with permission).*

Maureen Windsor (aged 3) was swept against the rear wall of the kitchen and apparently crushed against the chimney, being killed instantly. The landslide had, as in the 1936 disaster, broken through the rear wall of the house (Figure 3).

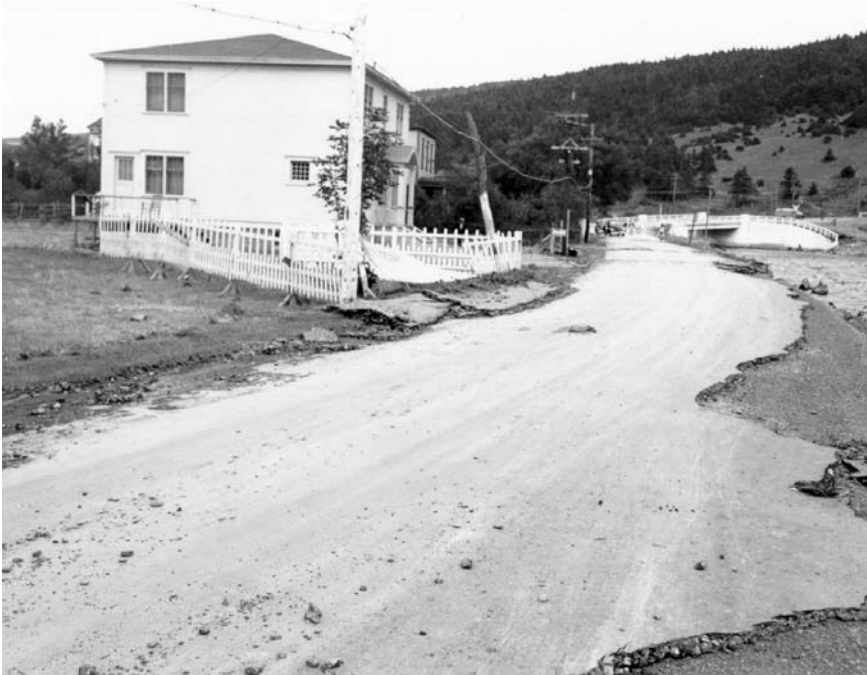
*Figure 4. Flood damage on Southside Road, September 1948 (St. John's City Archives, used with permission).*

for the flooding than the landslide. An *Evening Telegram* editorial (18 September) blamed poor planning for the flooding, which could have been prevented with proper culverting.

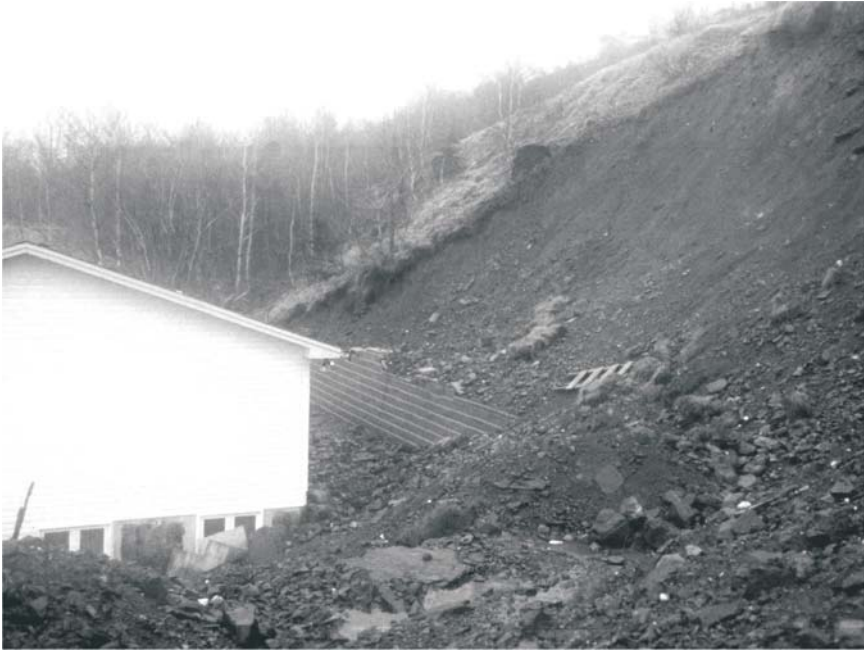
*Figure 5. Recent construction on Southside Road, undercutting steep banks of till and increasing landslide hazard.*

The slope stability and flooding problems no longer occur to the same extent, due to the construction of Pitts Memorial Drive in the early 1970s. This major highway is situated halfway up the slope, and much of the water that affected Southside Road is contained within ditches and culverts. Local residents state that flooding has not occurred for many years, although some difficulties persist along Symes Bridge Road. Slope stability, particularly rockfall, is still a problem on Pitts Memorial Drive after heavy rains and as a result of frost heaving. The road has been temporarily blocked completely or partially on several occasions since 1990. In spring 1996, a driver was injured when her vehicle hit rocks that had fallen into the road. Minor landslides have been observed on Southside Road after heavy rains. Currently, the City of St. John's, after consultation with the Newfoundland and Labrador Geological Survey, requires a geotechnical evaluation of slopes for any new construction in this area (Figure 5).

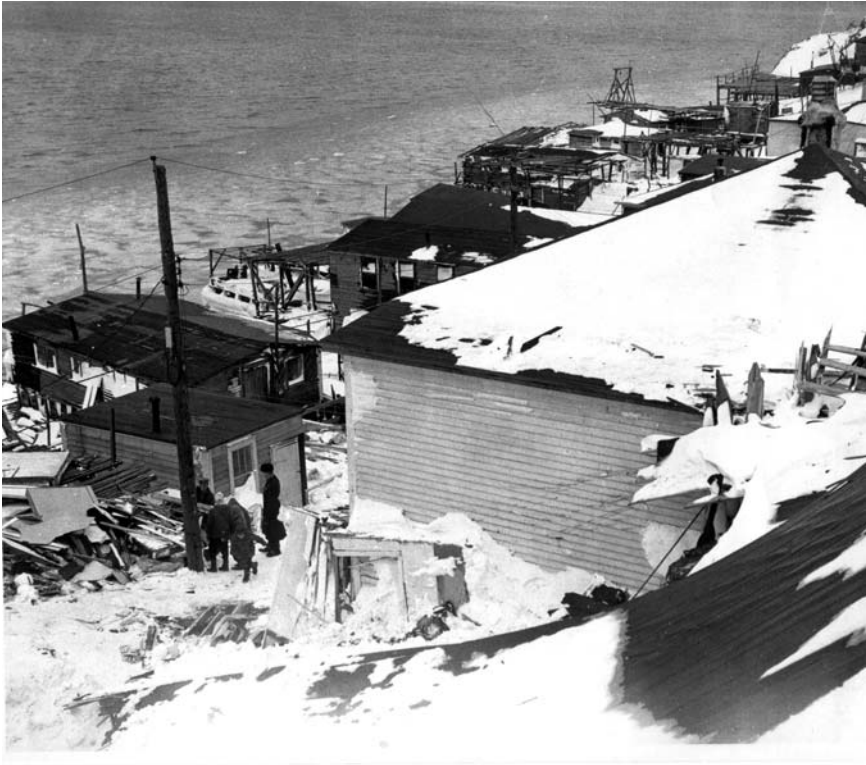
*Figure 6. Aftermath of the 1959 Battery avalanche (from the collection of Shirley Eales, used with permission).*

There are no records of further avalanches until 1959, when the worst geological disaster in St. John's history occurred. A ferocious storm hit St. John's on the night of 16 February, with winds reported up to 200 kilometres/hour, and depositing 55 centimetres (22 inches) of snow. At 1:05 a.m., residents in the Outer Battery heard a sound described as being louder than a clap of thunder. An avalanche struck two houses belonging to the families of Clarence Wells and Jim Piercey, sweeping them downslope and into the rear of two other houses. The houses contained 14 people who were all swept downslope and buried. Clarence Wells was the nephew of Alfred Wells, whose family was hit by the 1921 avalanche. The top storey of the Piercey house was ripped off, and the Wells house demolished (Figure 6).

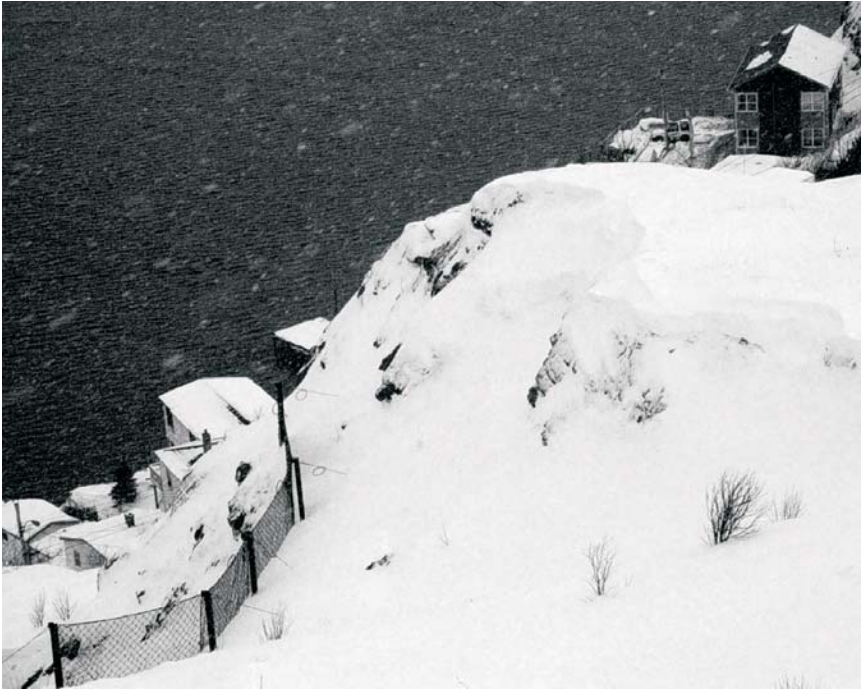
*Figure 7. Protective fencing erected above the Outer Battery in 1998.*

In October 1997, the City of St. John's let tenders on construction of safety fences and other measures to provide protection from rockfall and avalanche in the Outer Battery, with estimated costs in excess of \$300,000 (Figure 7). New warning signs have been placed on the North Head Trail to divert people from the slopes above the Battery. The protective fences were constructed in 1998 but have not yet been tested by a significant rockfall or avalanche.

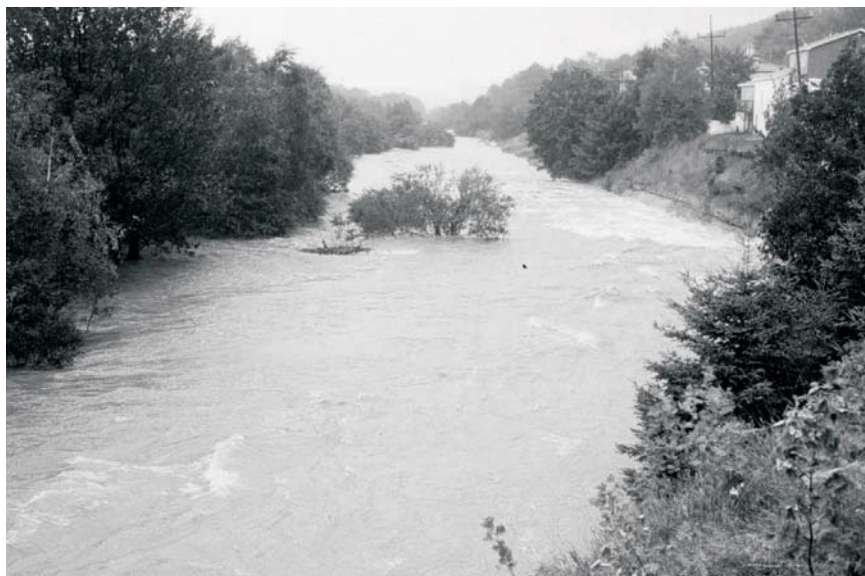
*Figure 8a. The Waterford River in full flood, 19 September 2001.*

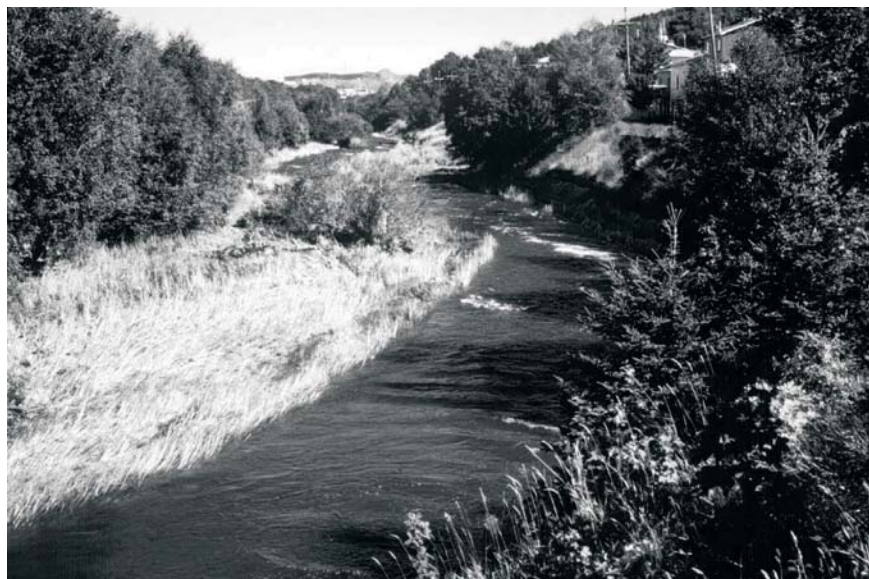
*Figure 8b. Waterford River 24 hours later, showing effect of flood, and rapid return to normal water levels.*

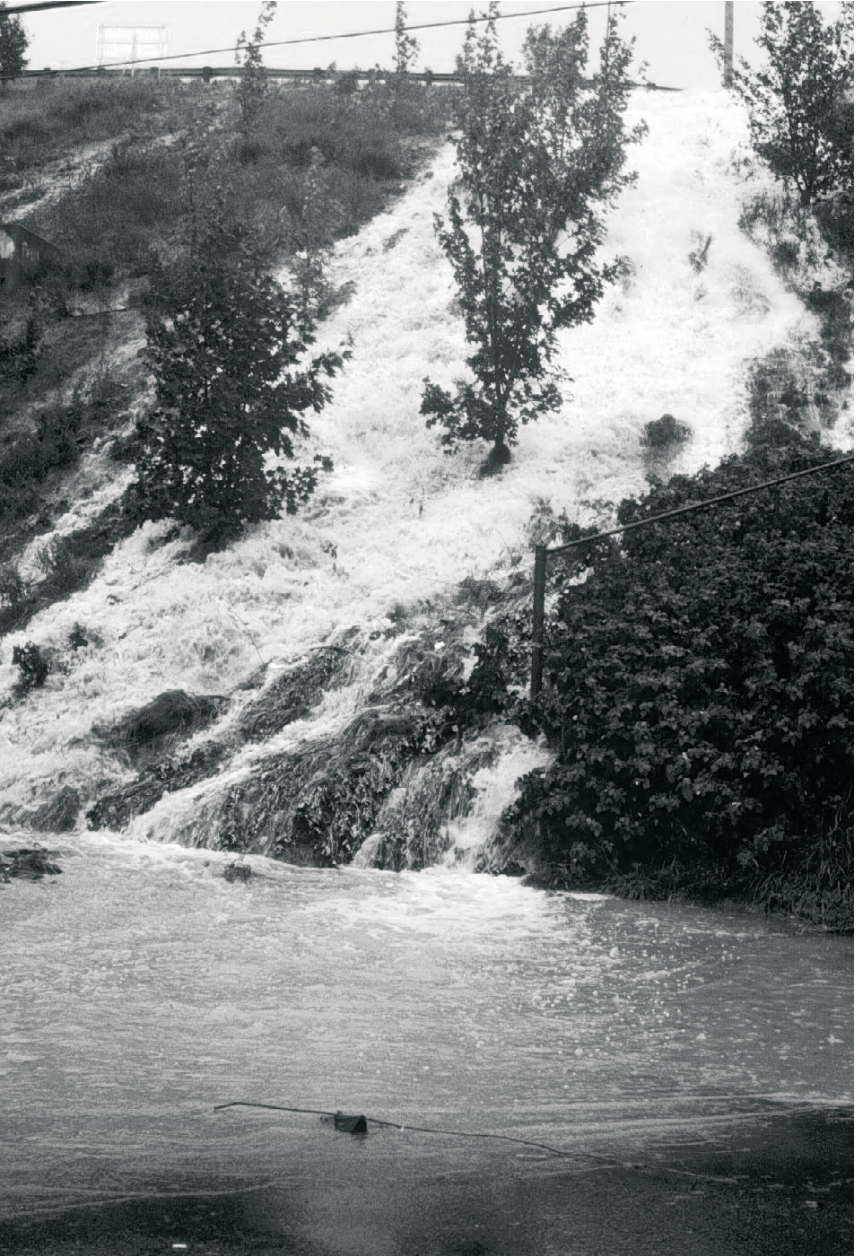
*Figure 9. Waterfall created on Southside Road during September 2001 floods.*

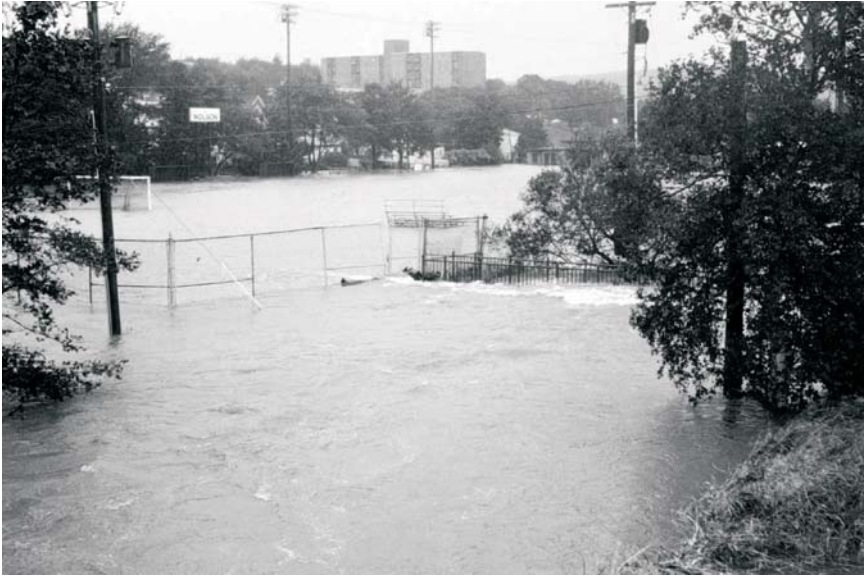
*Figure 10. Floods cover soccer field at head of Quidi Vidi Lake, September 2001. Note footbridge over Rennie's River forming dam as it blocks flood waters.*

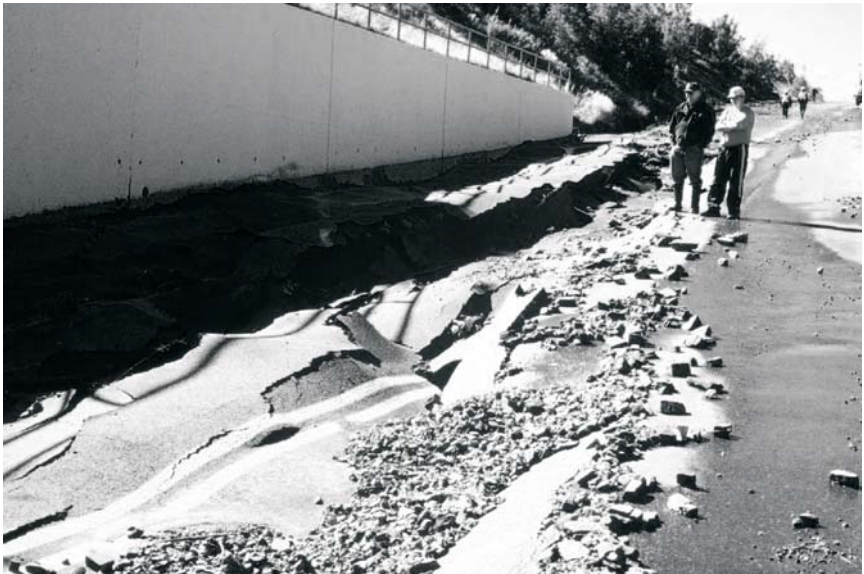
*Figure 11. Flood damage on Shea Heights road, September 2001.*

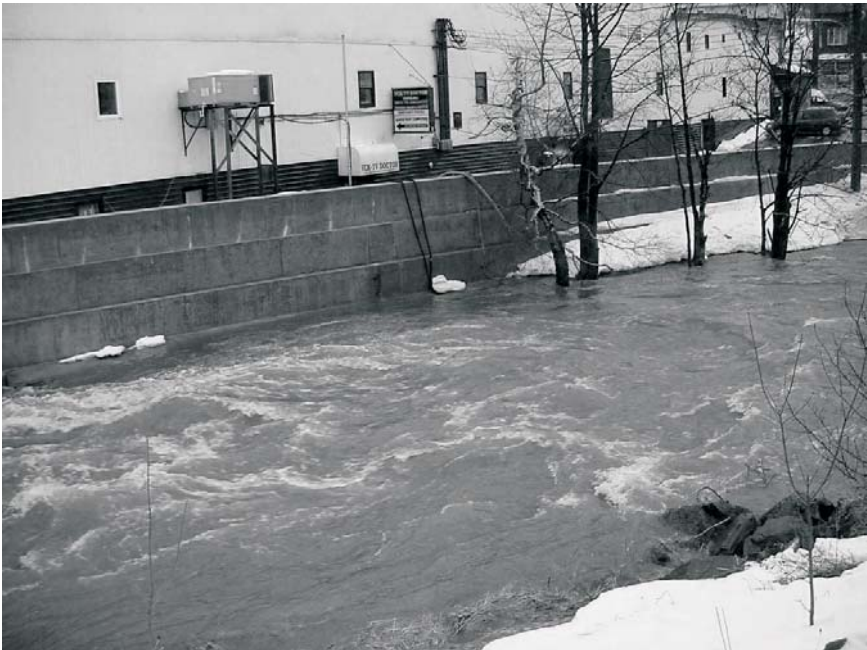
*Figure 12. Flood protection, Waterford River, constructed after 2001 flood.*

sional flooding. Thus by the 1940s, the area around Quidi Vidi Lake, previously mostly agricultural land, is often mentioned as being flooded, with houses damaged. By the 1960s, the Churchill Park-University Avenue-Avalon Mall area has been added to the area vulnerable to floods, and, by the 1980s, expansion of the city adjacent to the Virginia River, along Leary's Brook, and in the Goulds, meant that these areas were also vulnerable to flooding (Figure 12).
